Island Bay Cycleway Post-Construction Road Safety Audit

PEER REVIEW

PREPARED FOR THE WELLINGTON CITY COUNCIL

JUNE 2016

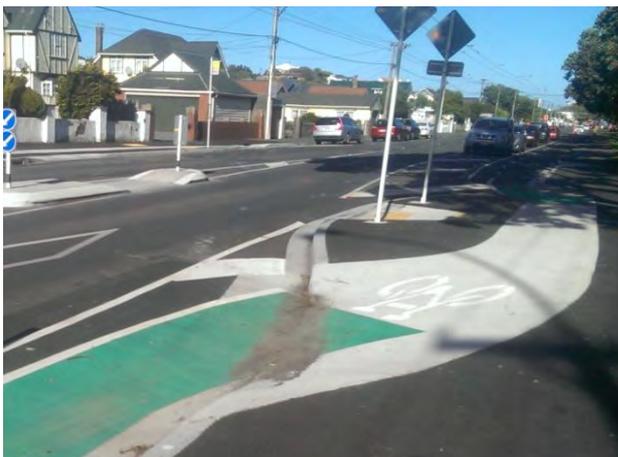
One of the transitions is located at a low point such that surface water and debris is pooling, see photo below. Cyclists, especially those not so sure of themselves, may perceive this as an obstacle (or if debris is built-up it may push the cyclist off course) and swerve away from the transition to the road or the kerb.

Figure 1: Surface water and debris pooling at cycleway transition

Review assessment	Frequency	Severity
	Occasional	Unlikely

Review the drainage design around the transitions of the cycle lane between the road level and footpath level. Regularly sweep the channel area to prevent debris build-up.

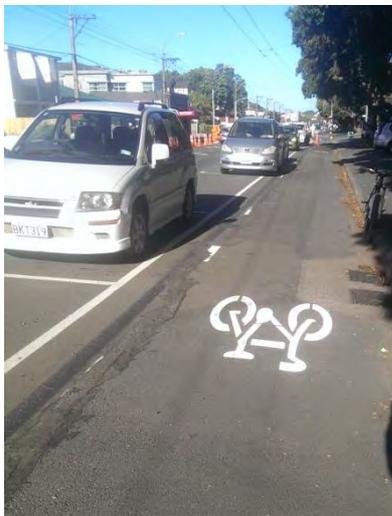
One area of paint marking for the buffer zone associated with the cycle lane was observed in an obscured/poor condition. Lack of definition of the buffer zone may result in poor parking compliance and provides inconsistent messages to cyclists about where they are expected to ride.

Figure 2: Buffer Zone marking poor condition

Review assessment	Frequency	Severity
	Infrequent	Unlikely

Repaint the buffer zone marking.
