## Bunny Street

Developed design stage

Safe system audit

Report prepared for  
**Wellington City Council**  
September 2025

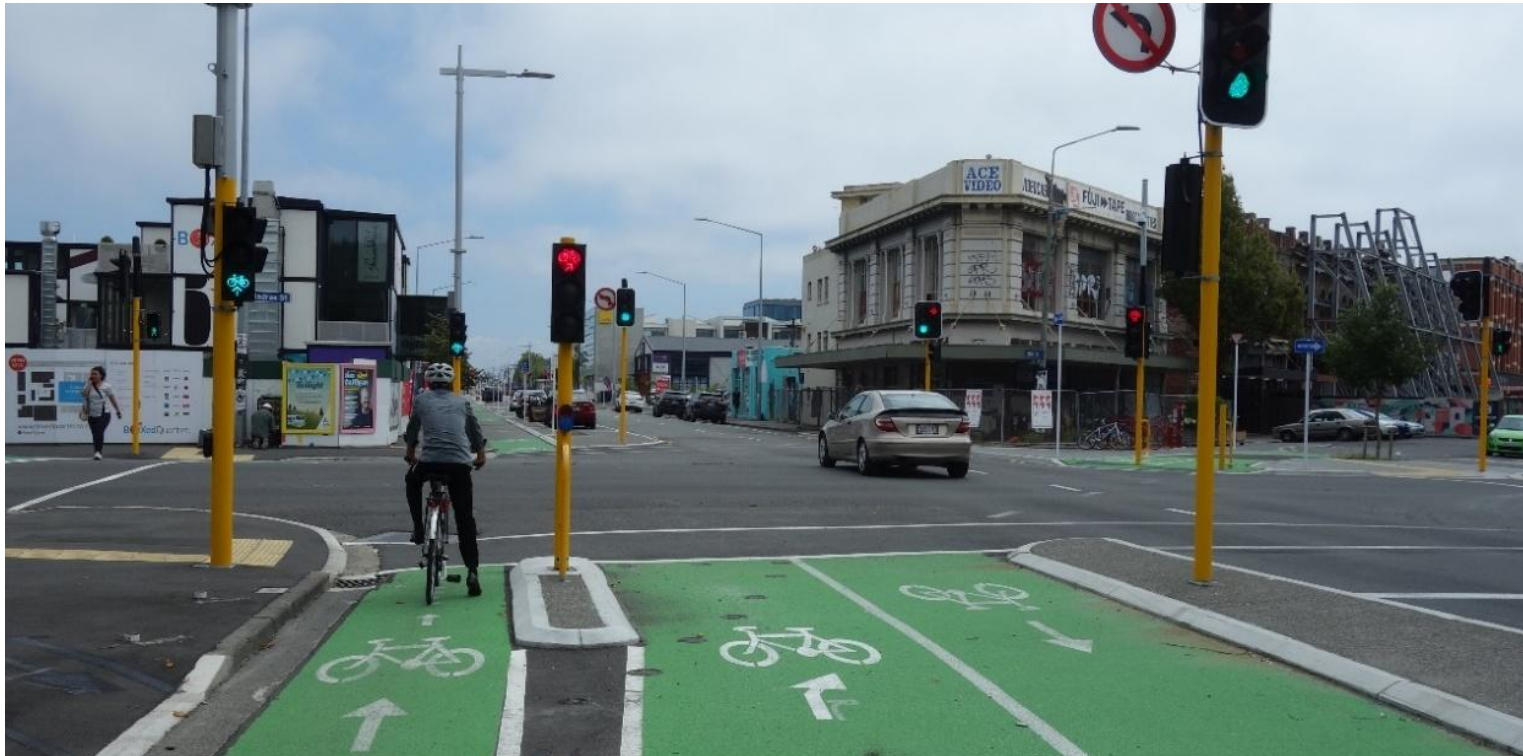
**Figure 3-3: Good distinction between signals for separated cycleway vs roadway, and signals for different cycle directions (St Asaph Street at High Street / Madras Street, Christchurch)**

This issue is more critical for the Bunny St cycleway approach. The design covers the first principle (separate approach lanes) but does not satisfy the other two principles. The SSAT acknowledges it would be tricky to achieve a splitter island between the two Bunny Street cycleway approach lanes on which to mount separate poles, but perhaps an overhead gantry for cycle signals could be achieved.

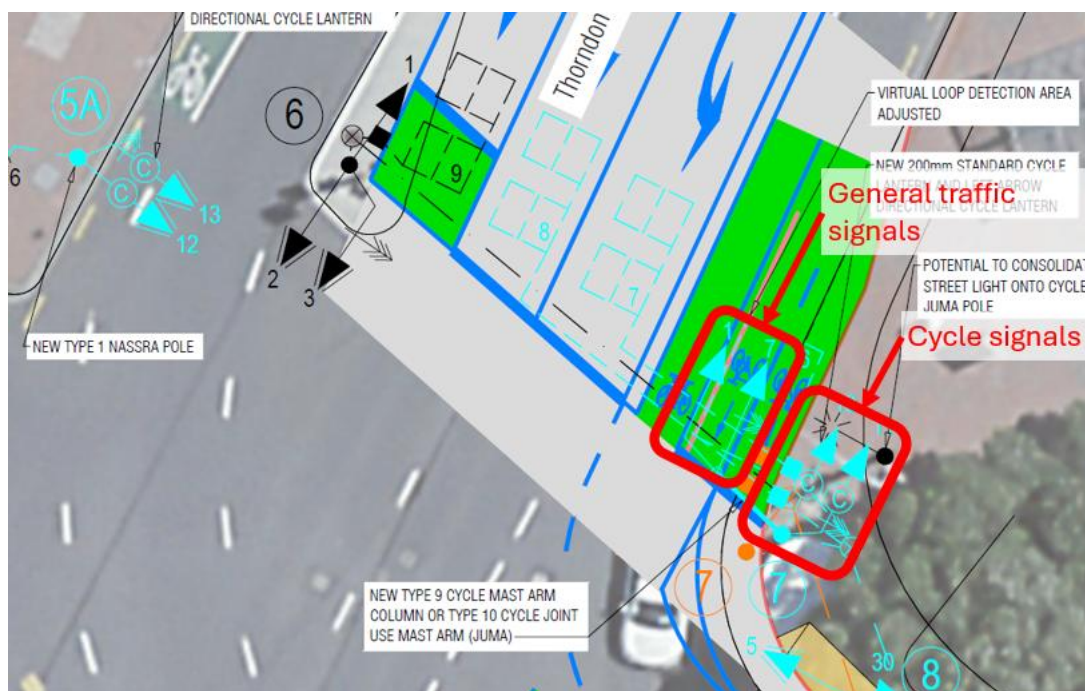
For the Thorndon Quay cycleway approach, the signals would be located next to the cycleway bend approach lane, and these cyclists would only face the risk of not proceeding when they are actually able to, which has no risk of conflict with motor traffic. Furthermore, while road-entering cyclists would have to look over

the adjacent cycleway lane to see their signals, the closest column to them would be the column relating to their movement. However, it appears that the general traffic signals would be located on a mast-arm with two columns located in a central position above the cycleway approach lanes (Figure 3-4), which could cause extra confusion for cyclists and result in them progressing when there is a green for general traffic but not for a cycleway movement.

**Figure 3-4: Thorndon Quay approach primary signals**

Concerns noted. Proposed design changes is to relocate the Thorndon Quay primary vehicle lanterns to an island between the traffic lane and cycleway. This would involve replacing a section of cycleway dividers with a 1.1m wide traffic island which provides sufficient clearance for a two column lantern. The cycleway would be narrowed to a 1.5m wide departure lane and two 1.25m wide approach lanes (no islands between cycleway lanes). A type 9 cycle mast arm column or type 10 cycle joint use mast arm would be located in the footpath (as previously proposed). A left turn cycle directional lantern would be mounted to the upright and a standard cycle lantern would be mounted on the outreach.

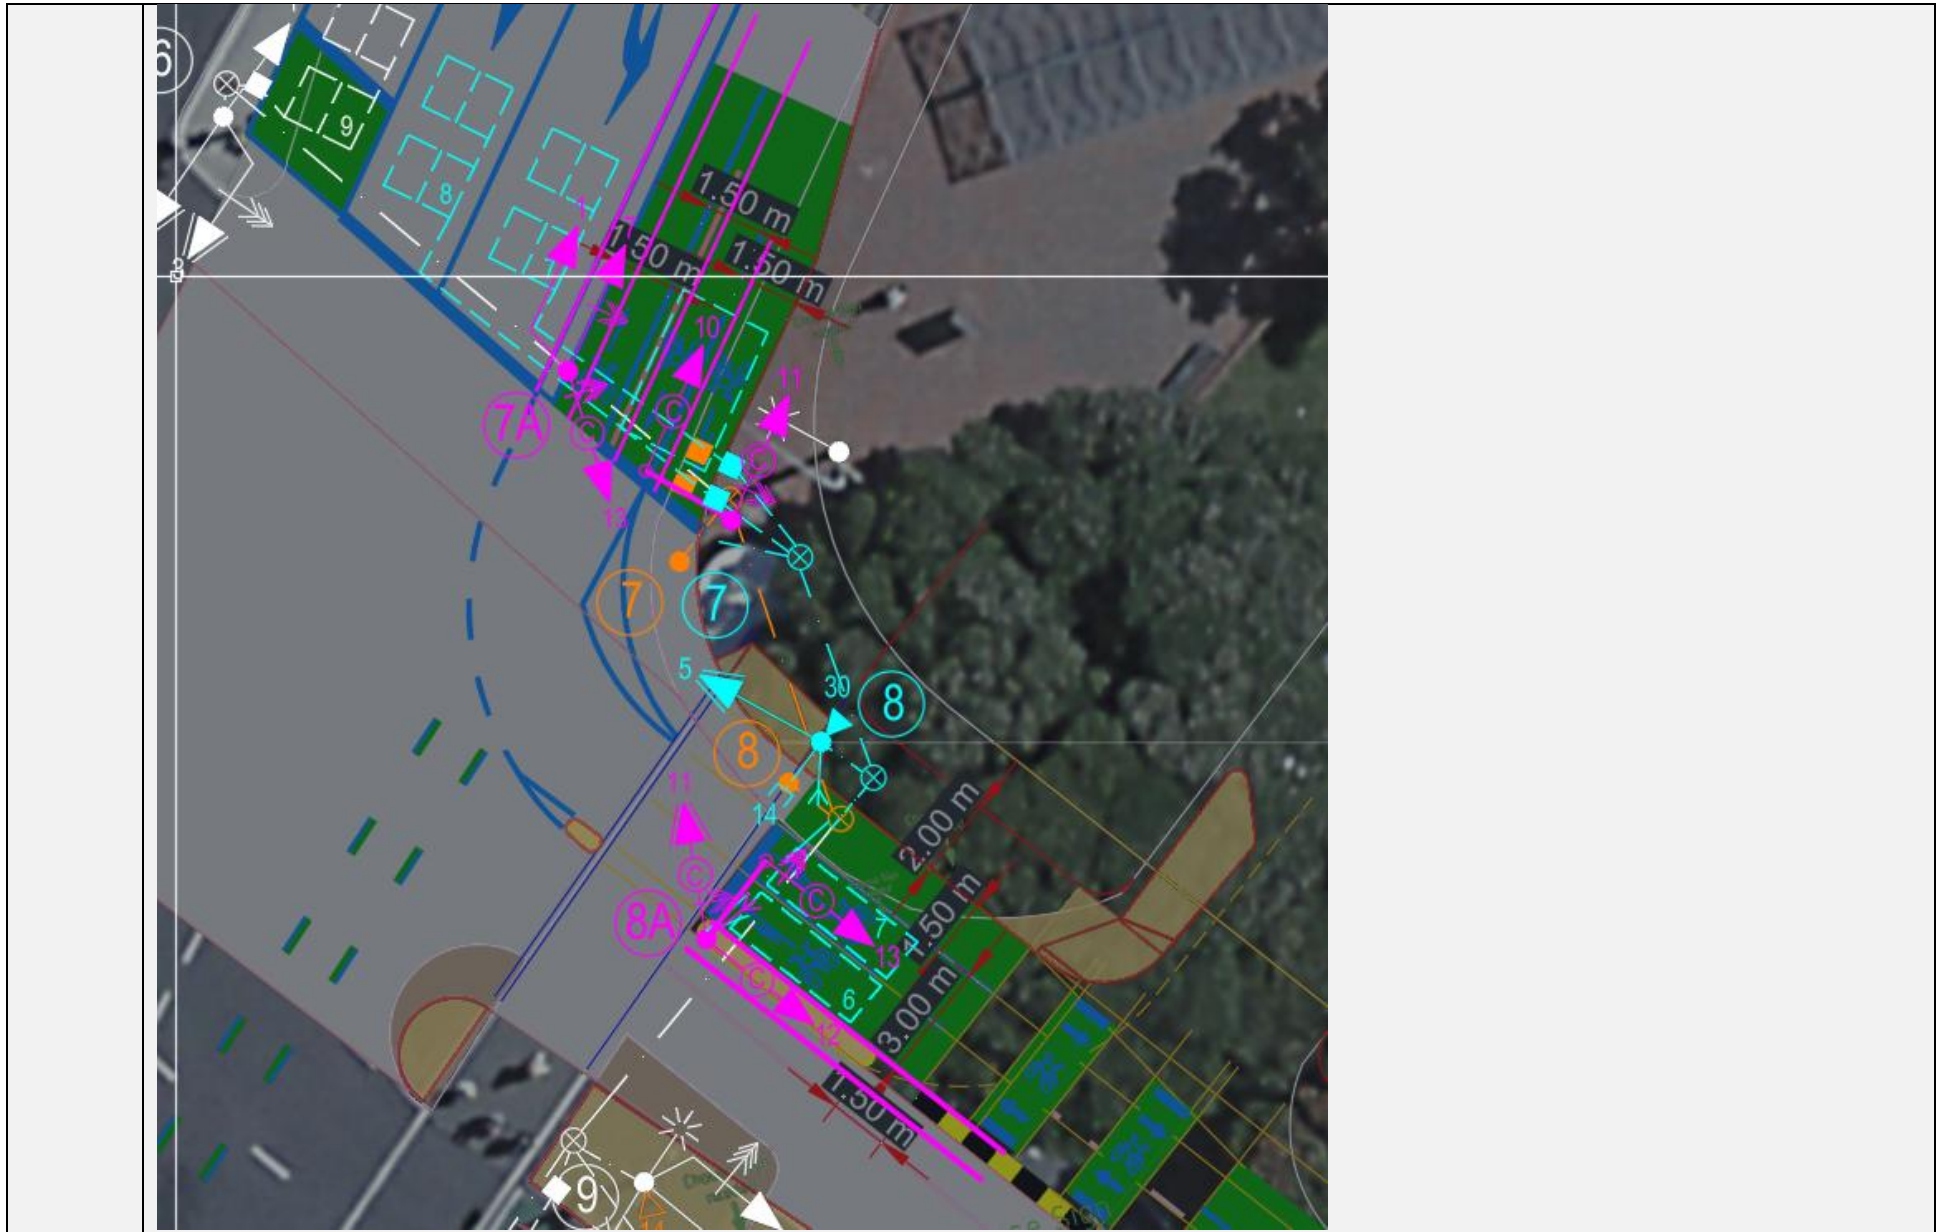
| <p>The safety issue is that cyclists entering the road from the Bunny Street or Thorndon Quay cycleway approaches might think the signals for the cycleway bend (SG 10 / SG 13) in the far-side position (i.e. on the departure side of the intersection) apply to them, and proceed during the wrong phase.</p> <p>The crash type expected is cyclist vs motor vehicle – depending on the phasing, the latter could be travelling at speeds likely to cause serious injury to a cyclist.</p> <p>The risk factors include:</p> <ul style="list-style-type: none"> <li>Both columns of cycle signals (those for cyclists entering the road and progressing across the intersection, plus those for cyclists continuing around the cycleway bend) are located on the same pole on the departure side of the intersection, which means: <ul style="list-style-type: none"> <li>cyclists continuing on the cycleway will probably not be looking in the direction of the far-side cycle signals, since they will be turning a short corner and not progressing across the intersection; and</li> <li>the far-side signals appear as if both columns are for cyclists entering the intersection; this is a particular concern for cyclists on the Bunny St on-road cycle lane or road-entering cycleway approaches who are planning on turning right onto the northbound on-road cycle lane on Thorndon Quay.</li> </ul> </li> <li>General lack of familiarity with directional cycle signals / multiple cycle signal columns for a signal approach.</li> <li>People react to change – even if they understand the difference between the two cycle signals, road-entering cyclists may make a false start when they see SG 10 / SG 13 go green.</li> <li>Compounding effects with other issues discussed in issues 3.1.2 and 3.1.4.</li> </ul> | Probability of crash occurring | Unlikely |

| <b>Designer</b> | Concerns noted, proposed design changes are: <ul style="list-style-type: none"><li>• Mount far side SG11 lantern on new pole 8A in the island between traffic lane and cycleway which is visible to cyclists turning left. This leaves the SG10 cycle lantern on pole 1 for cyclists travelling to Featherston St</li><li>• Mount far side SG 13 lantern on a new standard pole between the traffic lane and cycleway which is immediately behind the departure side cycle lane for cyclists turning right into Thorndon Quay. This leaves the SG12 cycle lantern on pole 5A for cyclists going to Bunny St west</li></ul> |

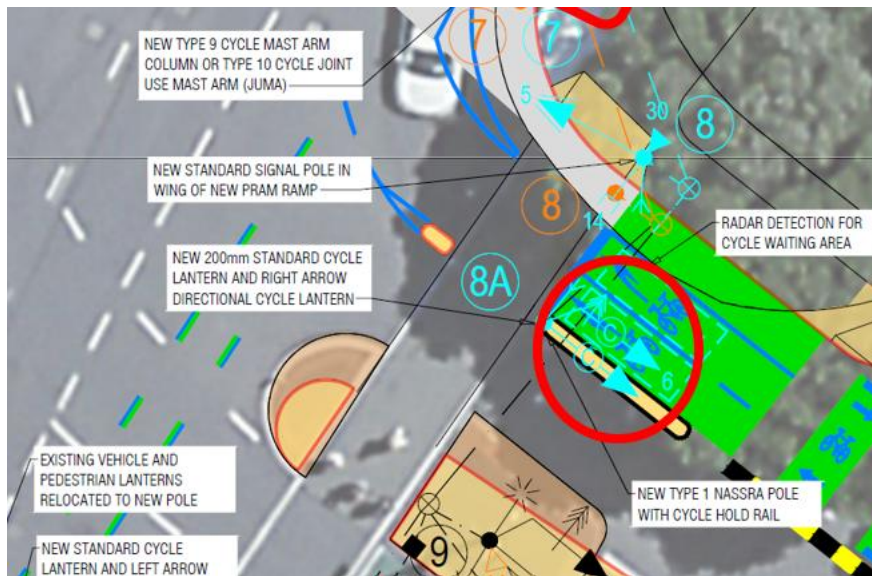
As shown in Figure 3-6, the signal group numbers (12 and 13) have been omitted from the primary cycle signals on the Bunny Street cycleway approach.

**Figure 3-6: Signal group numbers for Bunny Street primary cycle signals missing**

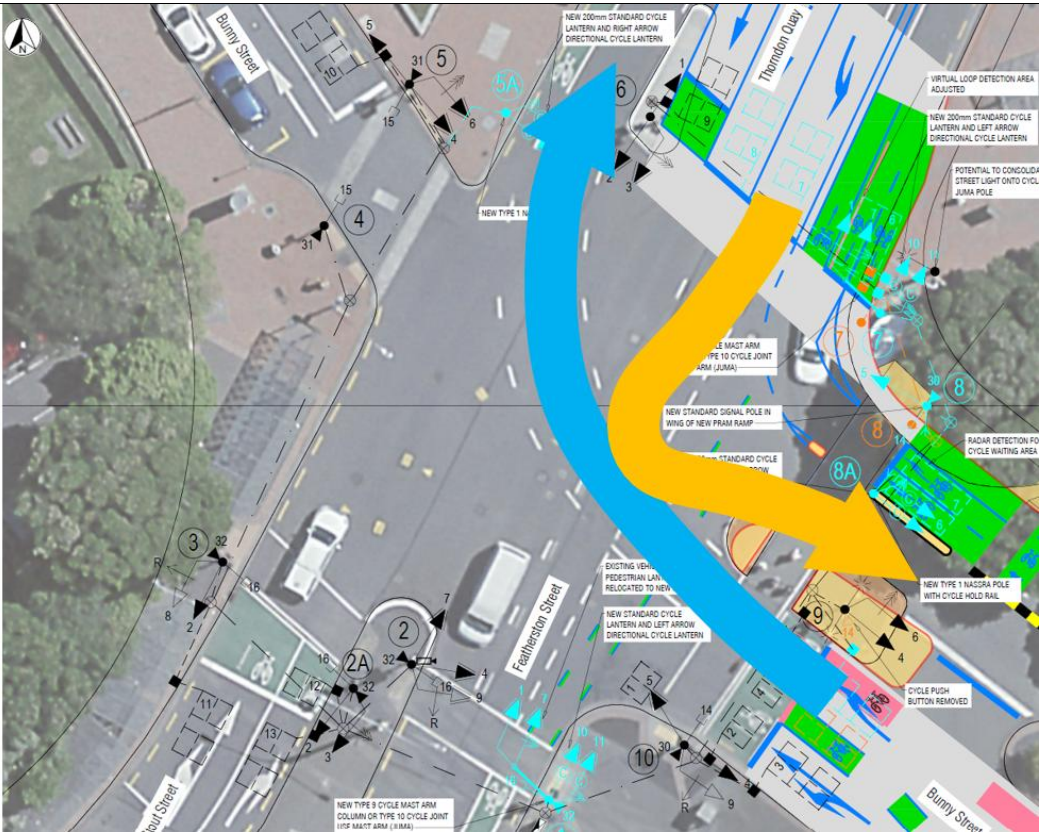
Figure 3-7: Crude attempt at trying to understand why these turns can't run in the same phase

| | 3.1.8.1 | Confirm via vehicle tracking whether the movements in Figure 3-7 can run in the same phase, and whether the island nose will get run over. | |

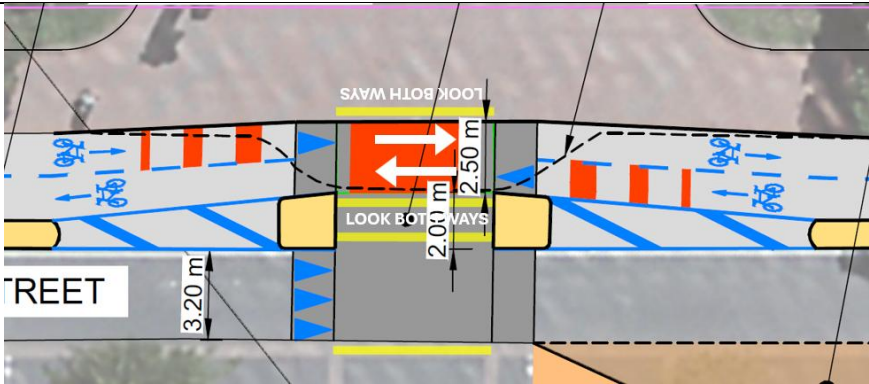
Figure 3-8: Proposed marking additions at pedestrian-cycle conflict point

| | 3.2.2.2 | Add arrows showing cycleway directions across the pedestrian crossing (see Figure 3-8). | |
| | 3.2.2.3 | Add “look both ways” markings approaching the conflict point (see Figure 3-8). | |

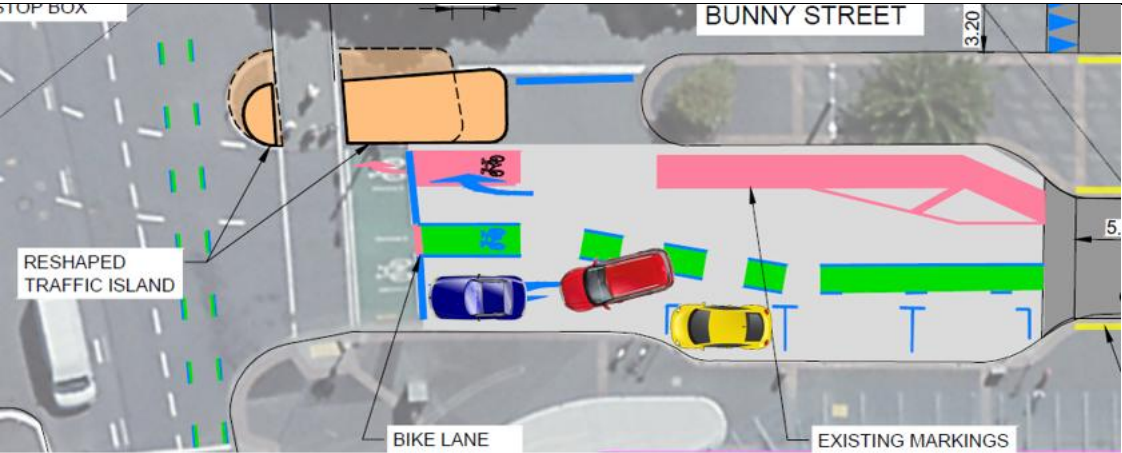
Figure 3-10: Vehicles anticipated to block cycleway approaching Featherston St

| | 3.2.4.2 | Begin the cycle lane taper earlier (i.e. further east), corresponding with the widening of the traffic lanes, to achieve more clearance between the cycle lane and the left-turn / through lane. | |

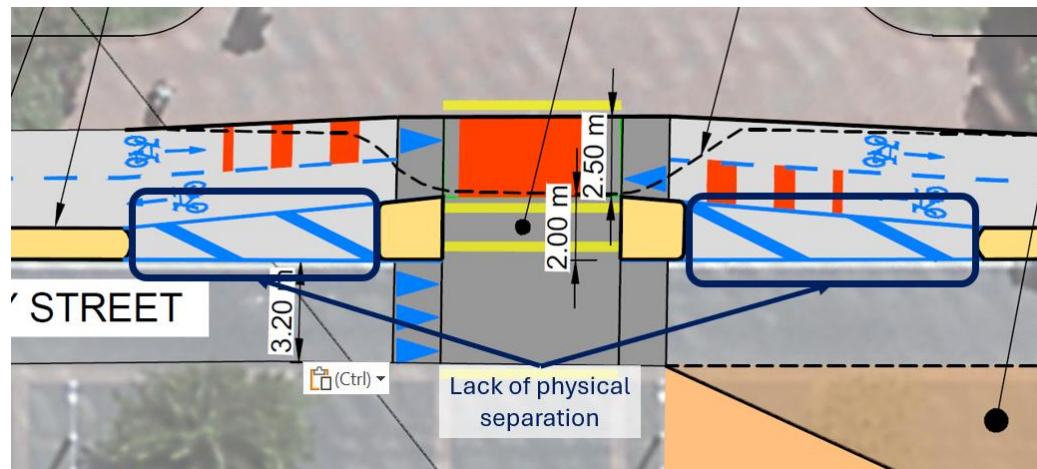
**Figure 3-11: Missing physical separation in vicinity of pedestrian crossing**

| <b>Designer</b> | Agree with parking concern, can add broken yellow lines to hatch area. Previous concern raised about pedestrians tripping on cycleway separator which is why a section of cycleway separator was removed from the design |

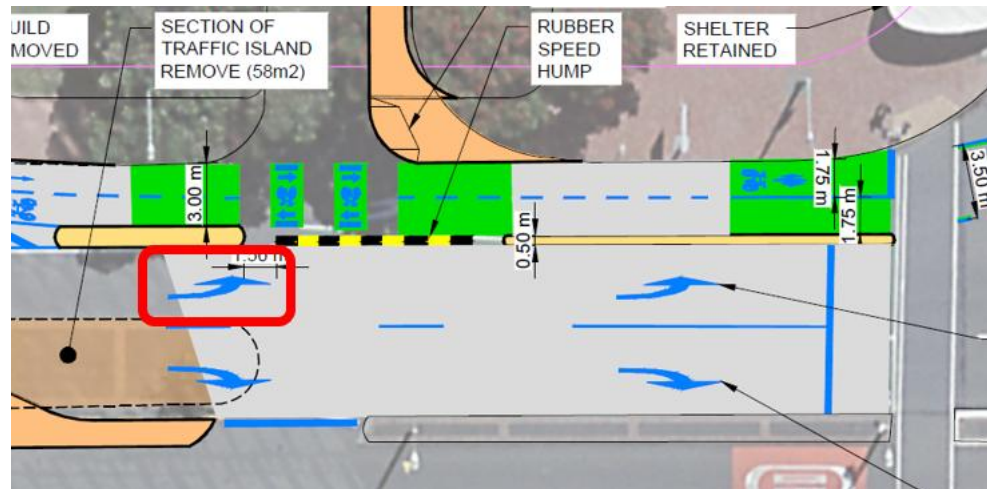
The safety issue is that drivers on Bunny Street might try to turn into the taxi loop exit, due to the positioning of the left-turn arrow marking (see Figure 3-12)

The crash type expected is head-on motor vehicle vs motor vehicle (if a driver turns in unaware that a taxi is exiting) or right-angle motor vehicle vs cyclist (if a driver realises their error but gets flustered and fails to check for cyclists).

**Figure 3-12: Confusing left-turn arrow approaching taxi loop exit**

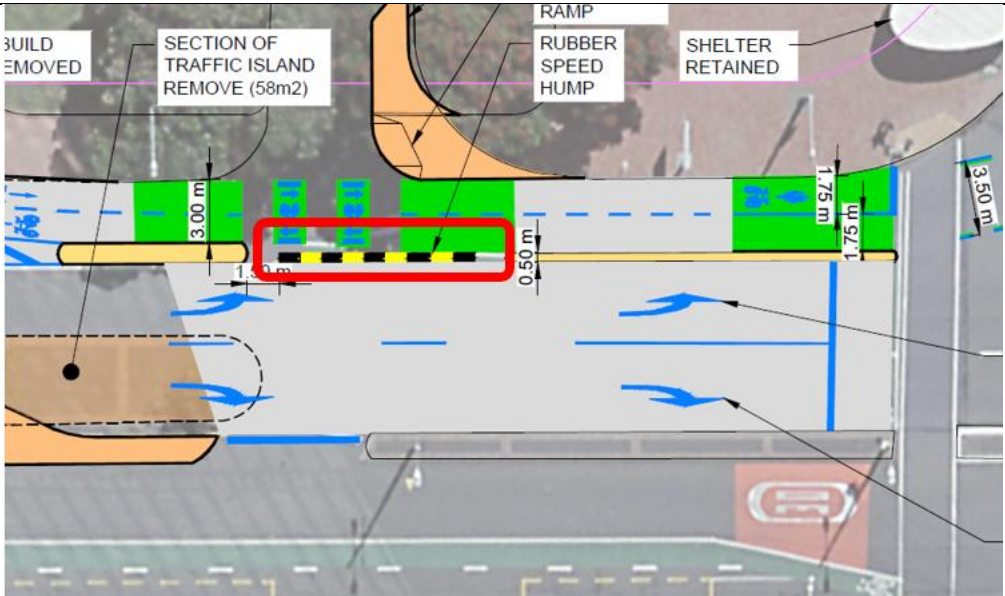
Figure 3-13: Proposed speed calming device will not slow vehicles exiting taxi loop prior to cycleway

| | 3.2.7.2 | In accordance with issue 3.2.6, retain the incorrectly positioned speed hump indicated in Figure 3-13, to help deter the wrong turn into the taxi exit. |

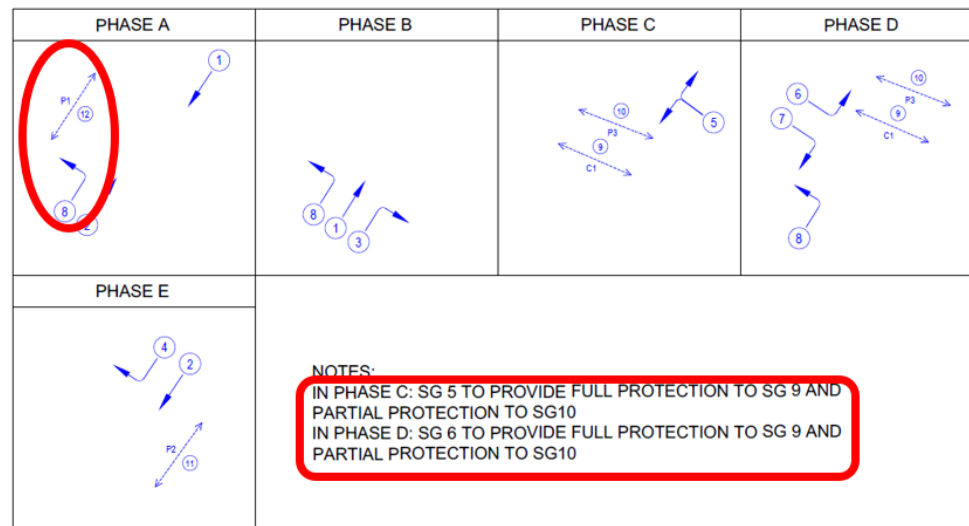
- High pedestrian volumes
- Inconsistency with other crosswalks at this intersection and other intersections throughout the city, where pedestrian protection is the norm
- Intersection geometry allows for a reasonably fast left turn in this location

The relevant guidance is the [Stops and Goes of Traffic Signals](#) which states “Where the number of pedestrian/vehicle conflicts is high, pedestrian protection using red arrow control should be considered.”

**Figure 3-15: No protection to SG 12**

| <b>Safety Engineer</b> | Recommend partial ped protection for both SG9 and SG10. Don't need full protection as left turners in D phase would get ~5 seconds of green time. Agree with partial ped protection for SG8 (as per existing operation). |

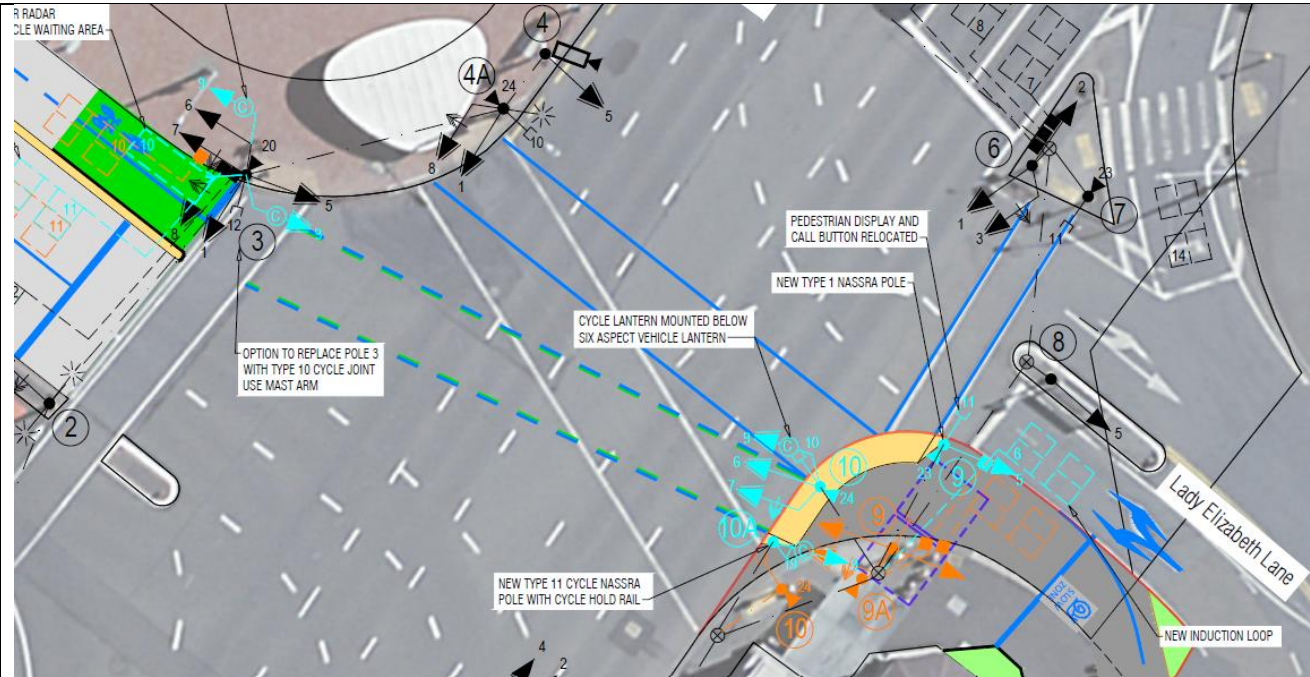
Figure 3-16: Diverging crossings from Lady Elizabeth Lane side

| | 3.3.3.2 | Mark the cycle crossing waiting area with green paint/tactiles and cycle symbols. |
| | 3.3.3.3 | Mark the pedestrian crossing waiting area with yellow tactiles and pedestrian symbols. |
