AUGUST 2023

Wellington City Council.

Wellington Central Fire Station.
Cycle Lane Behavioural Study.

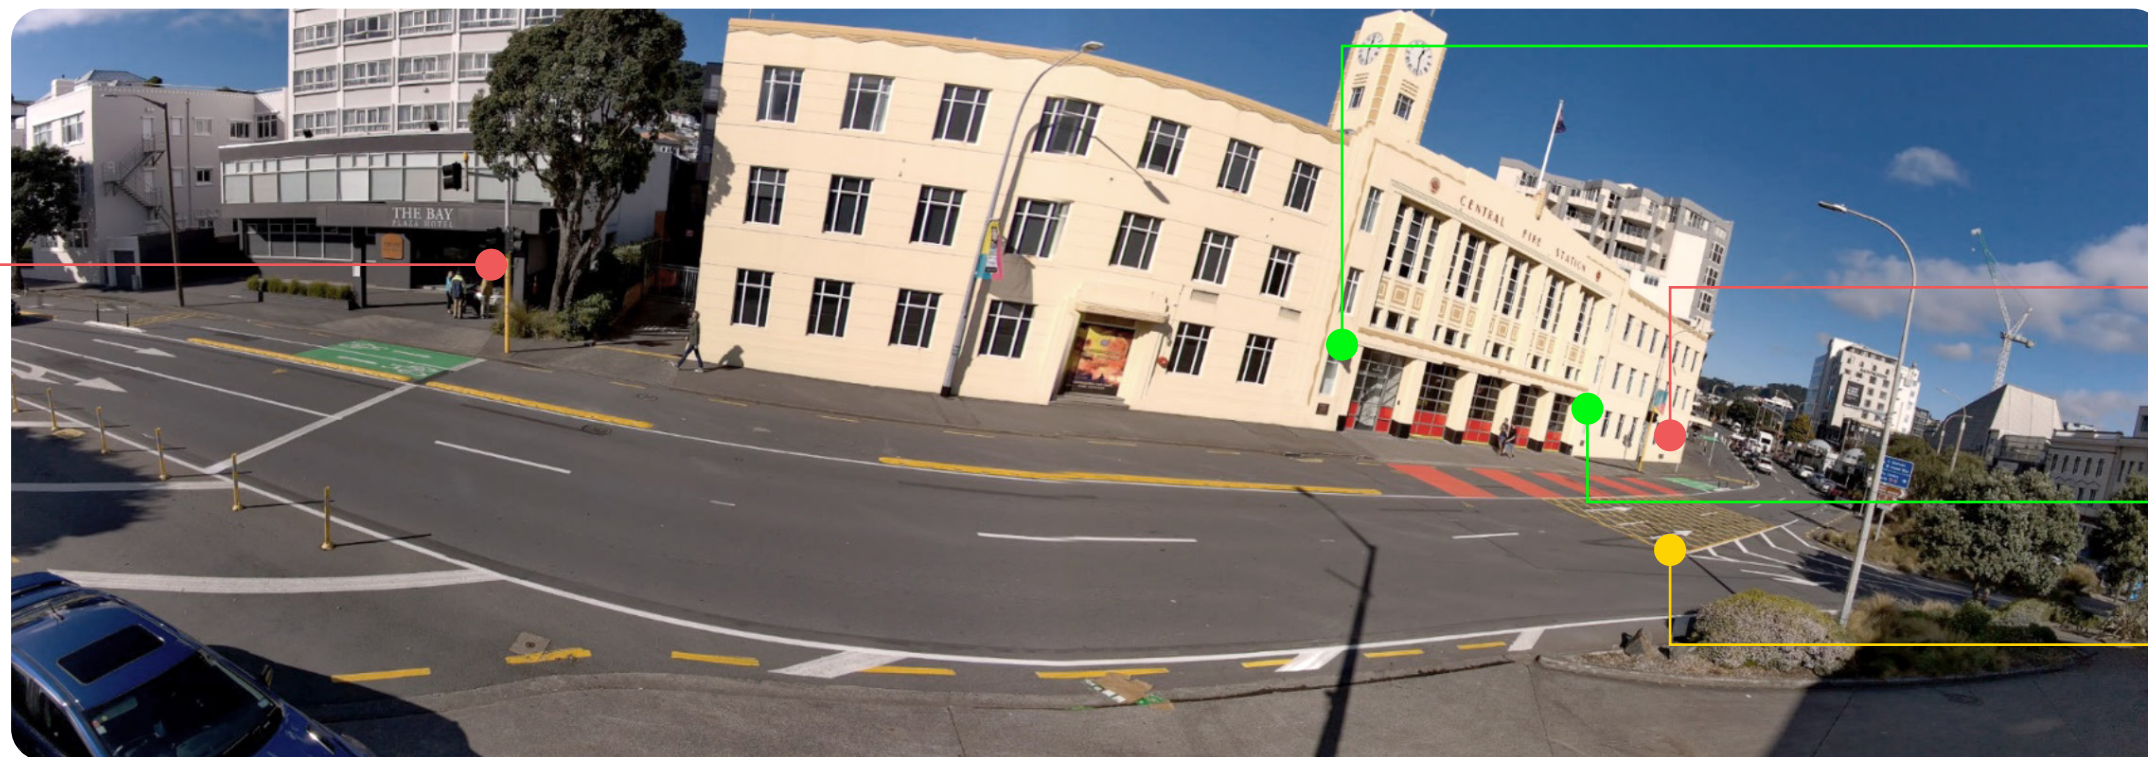
Outside of the Wellington Central Fire Station is a one way street and a bi-directional cycle lane, as well as a footpath. There are warning beacons on either side of the fire station which the fire station are expected to turn on when they are entering and/or exiting the building.

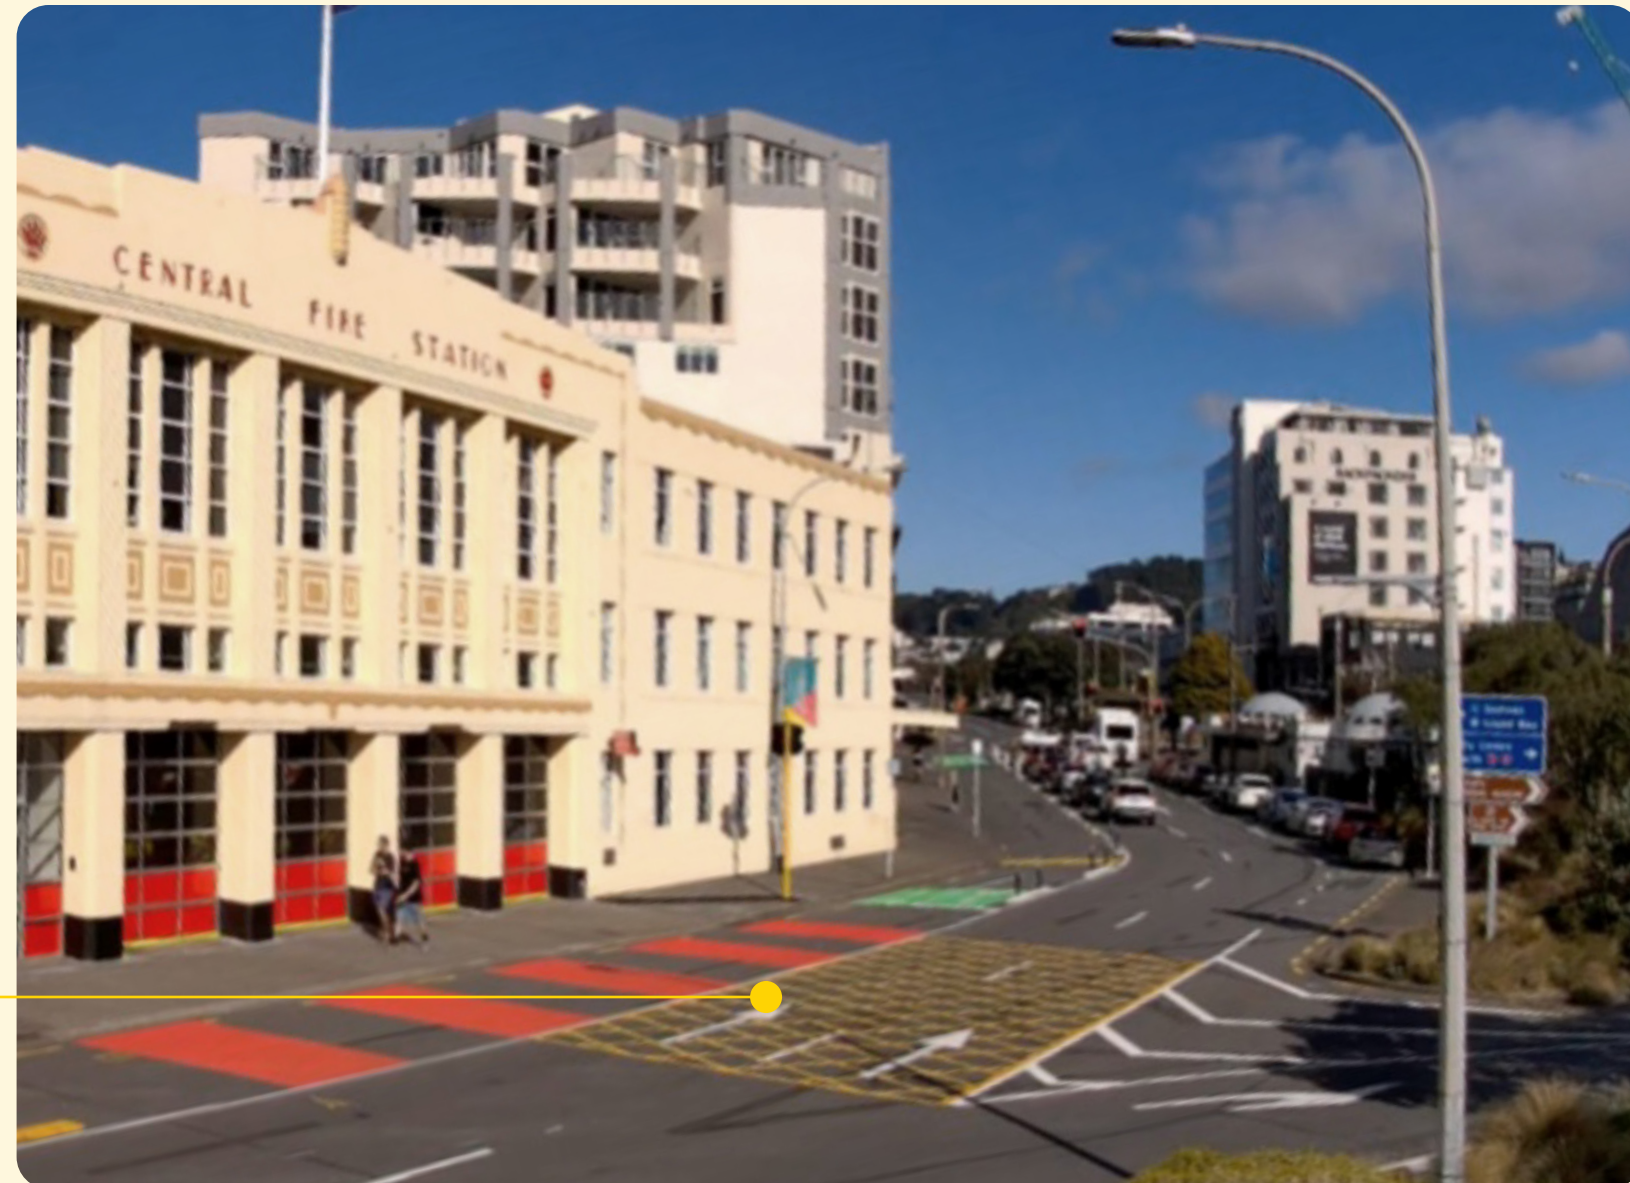
Yellow hatching zone.

It was also noticed that motor vehicles frequently stopped on the yellow hatching zone outside the fire station, while waiting for a traffic light change. On number of occasions this occurred while an appliance was attempting to exit the station.
