# Harbour Quays

Developed Design Stage Safe System Audit

Prepared for:  
Wellington City Council

Prepared by:  
Stantec

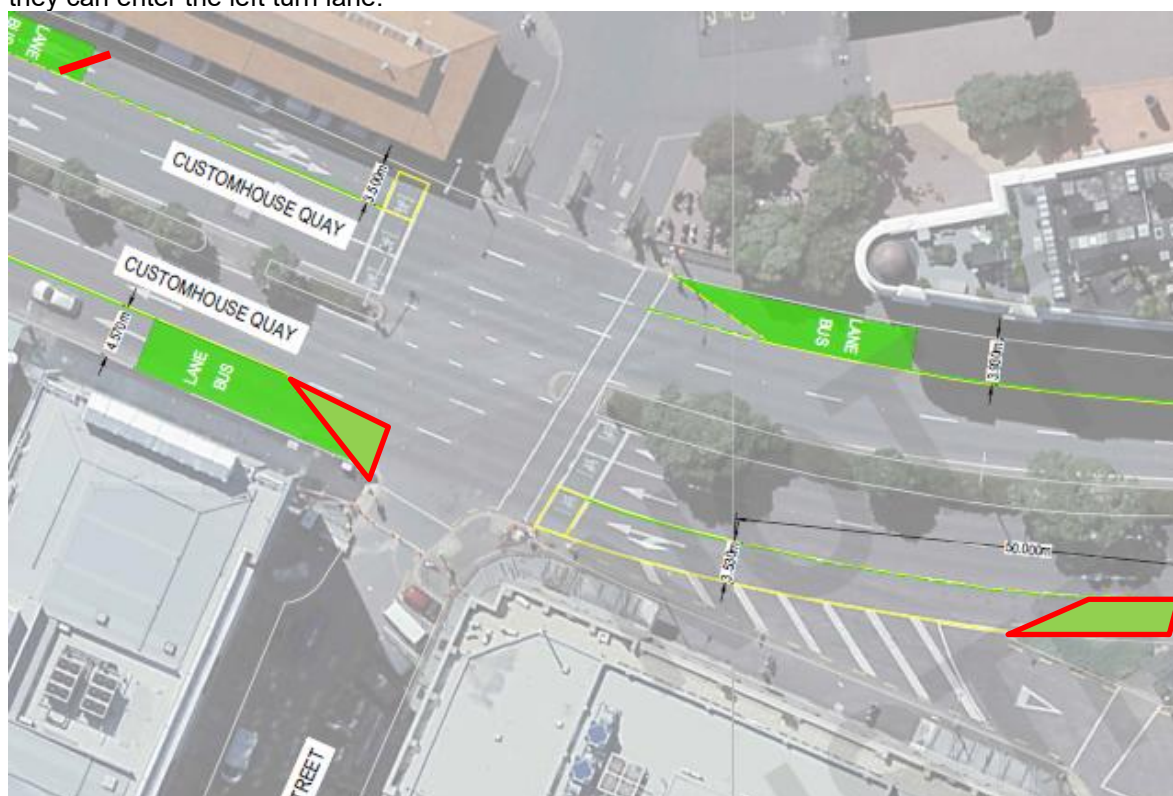
Figure 5-1: View of proposed Bus Lane markings near Brandon Street

As Brandon Street is one way westbound, there will not be any vehicles exiting Brandon Street onto Customhouse Quay. Therefore, there is no need to provide taper markings on the bus lane markings.

Additionally, for southbound motorists' intent on turning left into the harbourside/wharf area, there should be a sloping taper to indicate to motorists where they can enter the bus lane in order to turn left.

Similarly for motorists exiting left onto Jervois Quay from Customhouse Quay, there needs to be a taper and bus lane marking provided so that it is clear to motorists both exiting from Customhouse Quay as well as those already on Jervois Quay and wanting to turn left into Brandon Street where they can enter the left turn lane.

Severity outcome rating	The predominant outcome of a crash resulting from this safety concern is likely to be minor.
Risk ranking	The safety concern is therefore deemed to be minor.

1. Remove the proposed taper from the Bus Lane road markings immediately north of Brandon Street.
2. Provide a taper on the bus lane marking for southbound motorists so that it is clear to left turning motorists where they can enter the left turn lane.
3. Provide a bus lane marking with taper for northbound motorists in advance of the Customhouse Quay intersection with Jervois Quay so that it is clear to motorists' both on Jervois Quay and those exiting Customhouse Quay onto Jervois Quay where they can enter the left turn lane to access Brandon Street.

Design team response	Agreed – bus lane plan will be amended as per recommendations
Client safety engineer comment	Agree with Designer response.
Client decision	Progress designer response in detailed design.
Action taken	Bus lane to be amended during detailed design.

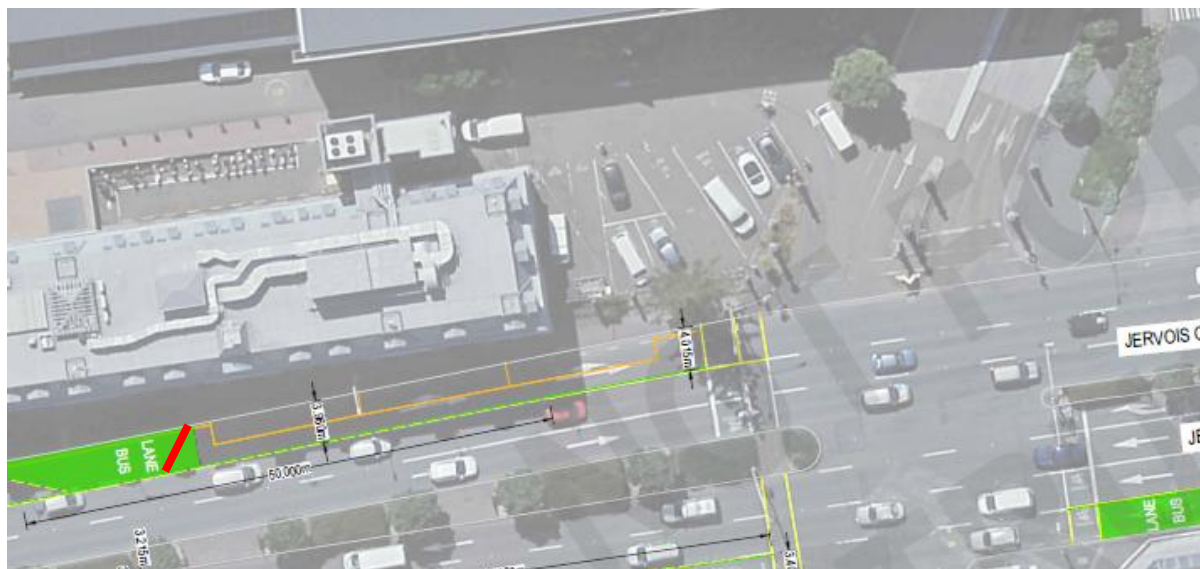
Figure 5-2: View of proposed Bus Lane markings near the entrance to the TSB Arena

The proposed bus stop for southbound buses on Jervois Quay leaves minimal space for left turning motorists to occupy the space in front of the bus. Therefore, there will be times when southbound motorists will be unable to access the left turn lane due to the presence of buses and as a result will block the southbound lane whilst waiting for buses to clear before they can enter the left turn lane.

To enable left turning motorists to access the left turn lane whilst buses are present, a bus priority early release phase should be implemented to enable buses to move clear and create space for left turning motorists.

Probability of a crash	Crashes resulting from this safety concern are likely
Severity outcome rating	The predominant outcome of a crash resulting from this safety concern is likely to be minor.
Risk ranking	The safety concern is therefore deemed to be moderate.

Design team response	Agreed – we will investigate the introduction of a bus release phase as per the recommendation as part of detailed design.
Client safety engineer comment	Agree with Designer response.
Client decision	Progress designer response in detailed design.
Action taken	Bus lane to be amended during detailed design.

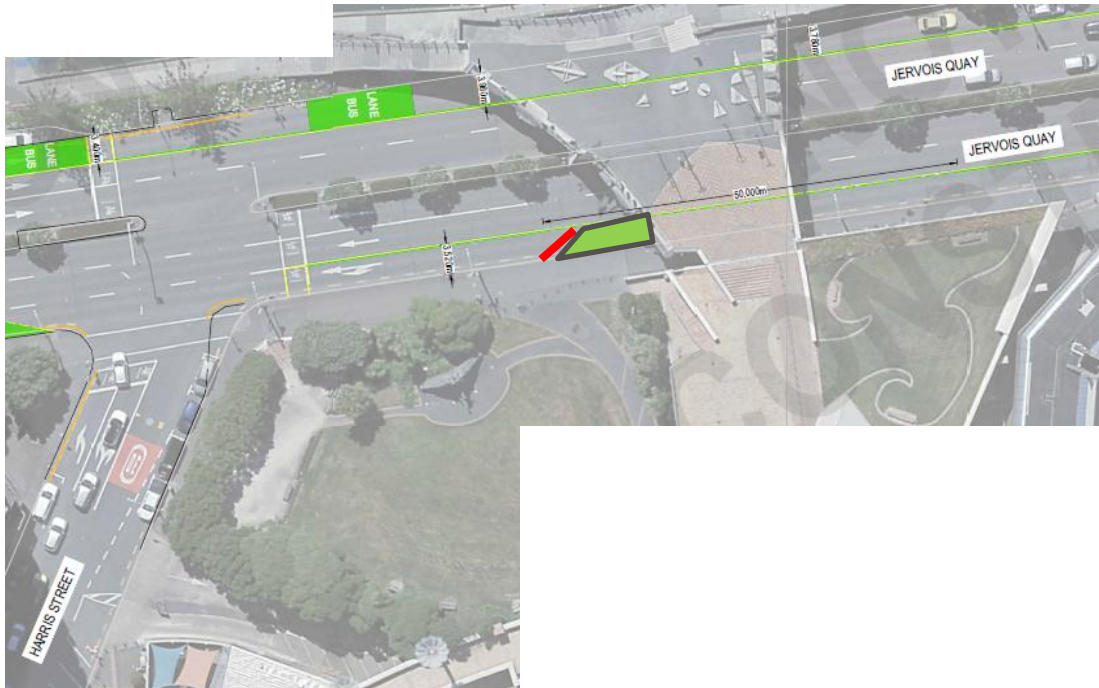
Figure 5-3: View of the northbound bus lane approach to Harris Street.

The northbound bus lane in advance of Harris Street is currently not provided with a bus lane marking with taper to indicate to left turning motorists where they are permitted to enter the left lane in order to turn left into Harris Street.

Design team response	Agreed – bus lane plan to be amended as per recommendation
Client safety engineer comment	Agree with Designer response.
Client decision	Progress designer response in detailed design
Action taken	Bus lane to be amended during detailed design.

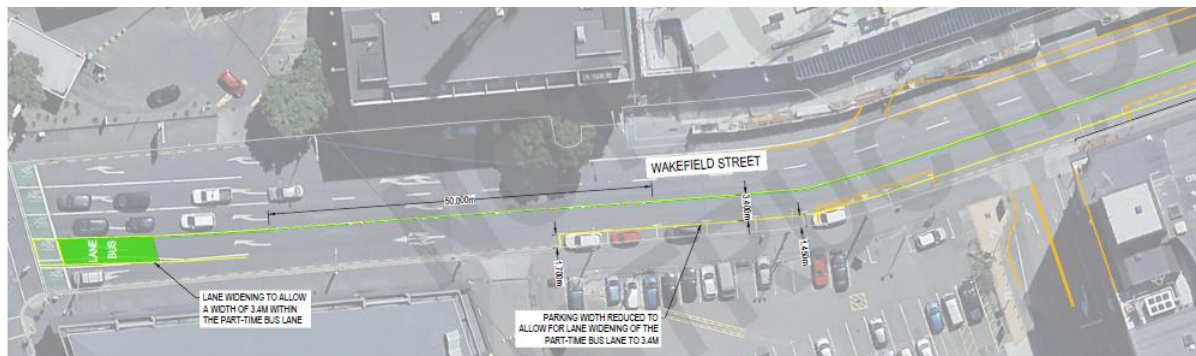
Figure 5-4: View of proposed Bus Lane markings northbound on Wakefield Street prior to Taranaki Street

The northbound bus lane in advance of Taranaki Street is currently not provided with a bus lane marking with taper to indicate to left turning motorists where they are permitted to enter the left lane in order to turn left into Taranaki Street.

Design team response	Agreed – bus lane plan to be amended as per recommendation.
Client safety engineer comment	Agree with Designer response.
Client decision	Progress designer response in detailed design
Action taken	Bus lane to be amended during detailed design.

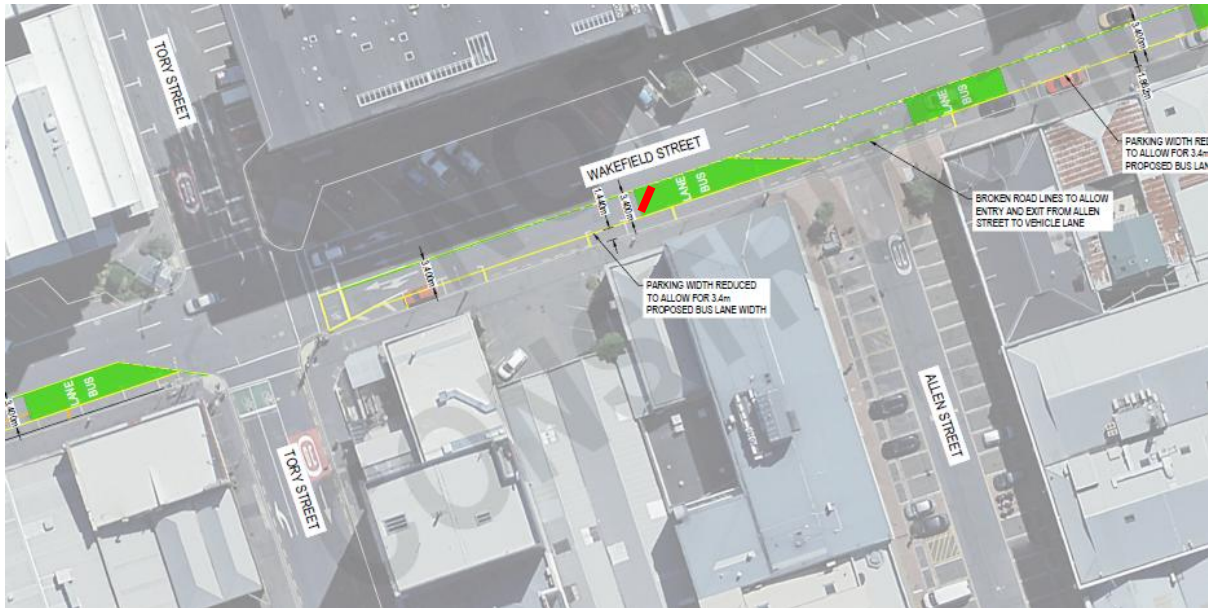
Figure 5-5: View of proposed Bus Lane markings on approach to Tory Street

The northbound Wakefield Road approach to Tory Street does not have a sloping entry marking on the proposed bus lane markings to indicate to left turning motorists where they should enter the bus lane in order to turn left into Tory Street (refer red bar in Figure 5-5 below).

Design team response	Agreed – bus lane plan to be amended as per recommendation
Client safety engineer comment	Agree with Designer response.
Client decision	Progress designer response in detailed design
Action taken	Bus lane to be amended during detailed design.

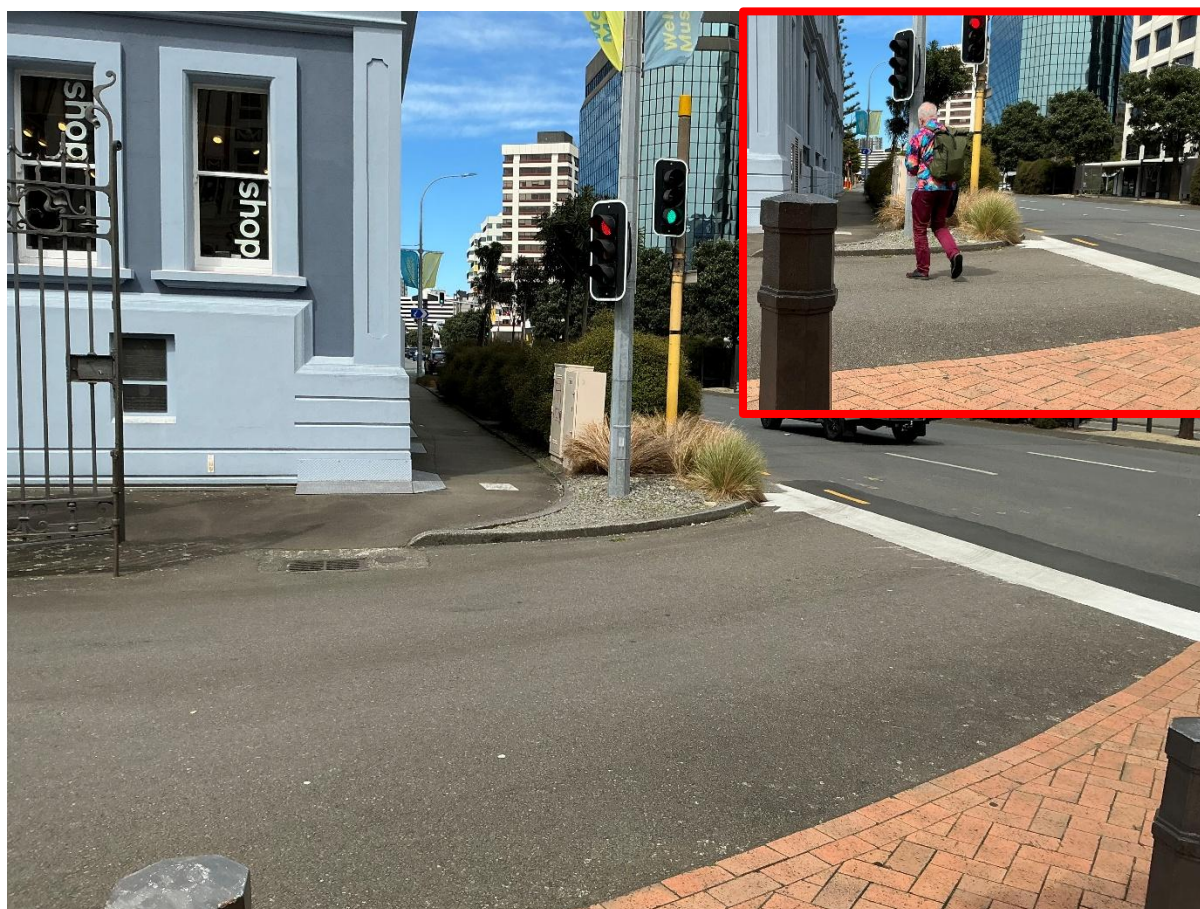
The existing left turn only exit from TSB Arena is signal controlled. However, there is no limit line to indicate where motorists should wait. In the proposed design there will be a pedestrian phase across this leg and therefore it will be important to ensure that left turning motorists do not obstruct the pedestrian desire line (refer INSET in Figure 5-6 below) across this leg.

Additionally, there are currently no pedestrian signal push buttons or pedestrian signal aspects to manage pedestrians crossing in this location.

Figure 5-6: View of exit from TSB Arena. Note lack of hold line. INSET: Pedestrian desire line.

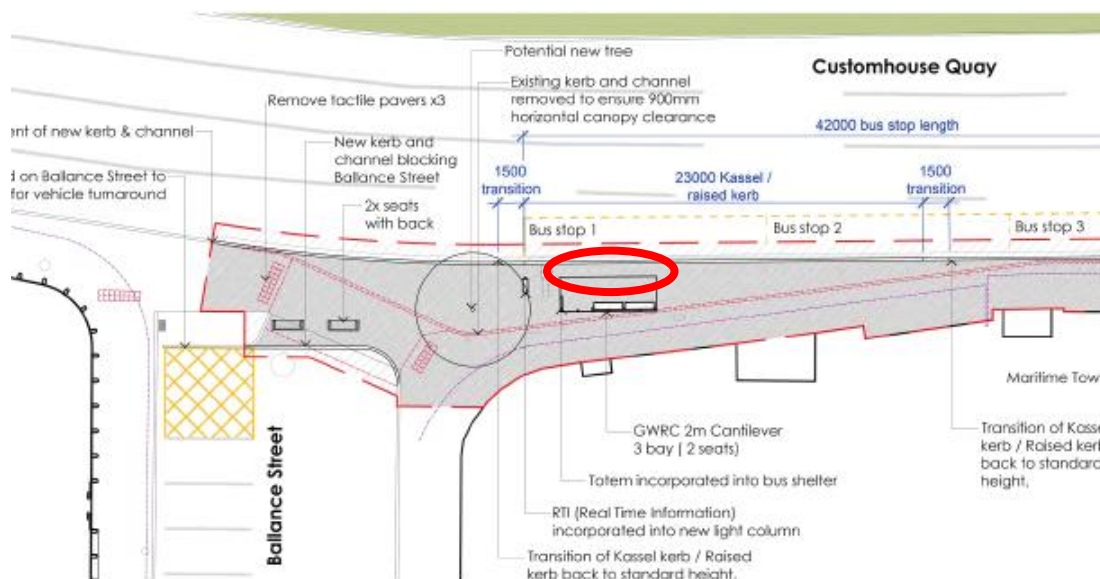
Figure 5-7: View of proposed layout near Ballance Street

The proposed bus shelter is located in close proximity to the new kerb and channel which provides minimal manoeuvring space for bus patrons to access the first bus at the bus stop. There is sufficient space in this area to increase the available footpath width in front of the proposed bus shelter.

Additionally, whilst on site the SAT observed a motorist attempt to exit from Ballance Street into Customhouse Quay. This manoeuvre increases the risk of collision with a driver turning left from Customhouse Quay into Ballance Street at this location. Whilst in the proposed plans Ballance Street will become a cul-de-sac, in the interim this risk remains. As such the provision of appropriate signage to direct drivers away from exiting onto Customhouse Quay from Ballance Street should be considered.

Design team response	Agree with recommendation 1 – we will investigate opportunities to provide additional footpath width at this stop location. Agree with recommendation 2 – noting that the obligation to provide appropriate signage for the existing intersection should not form part of the Harbour Quays project
Client safety engineer comment	Agree with Designer responses, notwithstanding the necessary signage should be shown in the Harbour Quays Project design.
Client decision	Recommendation 1 – This will be assessed during detailed design Recommendation 2 – To be handed over to maintenance
Action taken	Recommendation 1 – This will be assessed during detailed design Recommendation 2 – To be handed over to maintenance

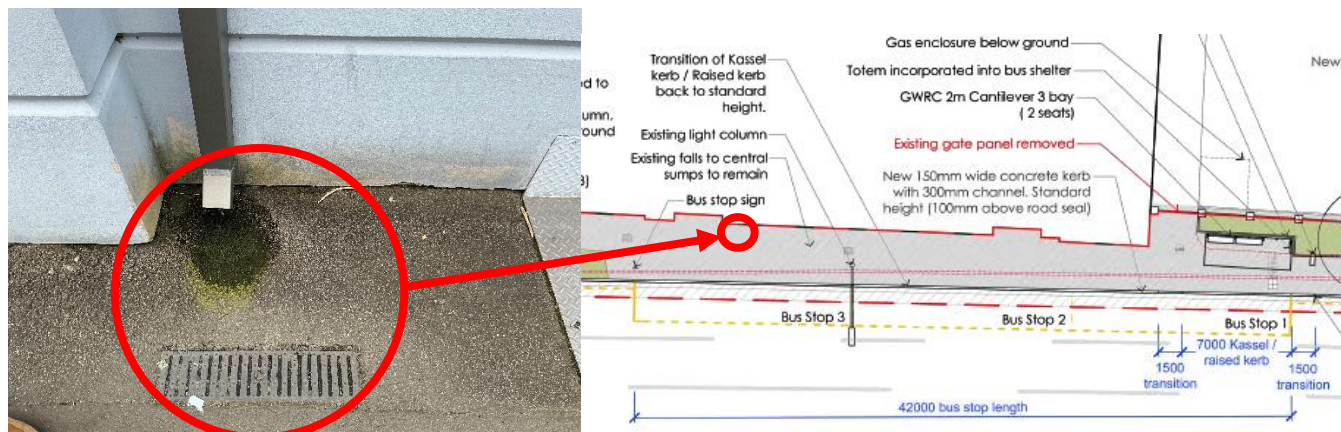
There is a downpipe which does not connect directly into the drain with the stormwater discharging directly onto the footpath prior to entering a nearby drain (refer to Figure 5-9 below). However, the drain appears to be partially blocked which would result in water covering the footpath in heavy rainfall events, increasing the risk of slips, trips and falls when this footpath becomes a route to the proposed bus stop.

Figure 5-8: View of blocked drain (left). Plan with red circle indicating location of drain.

1. Address the downpipe / drainage grill connection to ensure that the footpath does not create a slip hazard in heavy rainfall events.
2. Request drainage maintenance team review the timing of drainage sump / grill maintenance.

Design team response	Agree with observed issue – it is recommended that the blocked drain be reported to an appropriate maintenance group for resolution.
Client safety engineer comment	Agree with Designer response. Refer to Maintenance and Renewals
Client decision	Agree with designer response, to be referred to be maintenance and renewals.
Action taken	To be handed over to Maintenance to address.

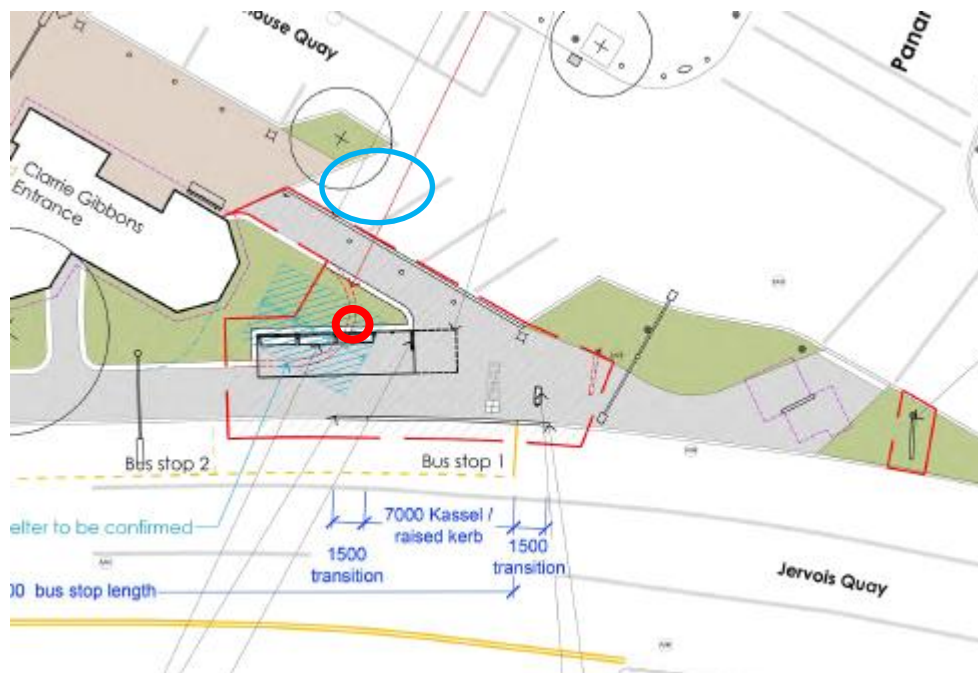
Figure 5-9: View of proposed layout at Post Office Square proposed Bus Stop. Red circle indicates position of existing parking meter.

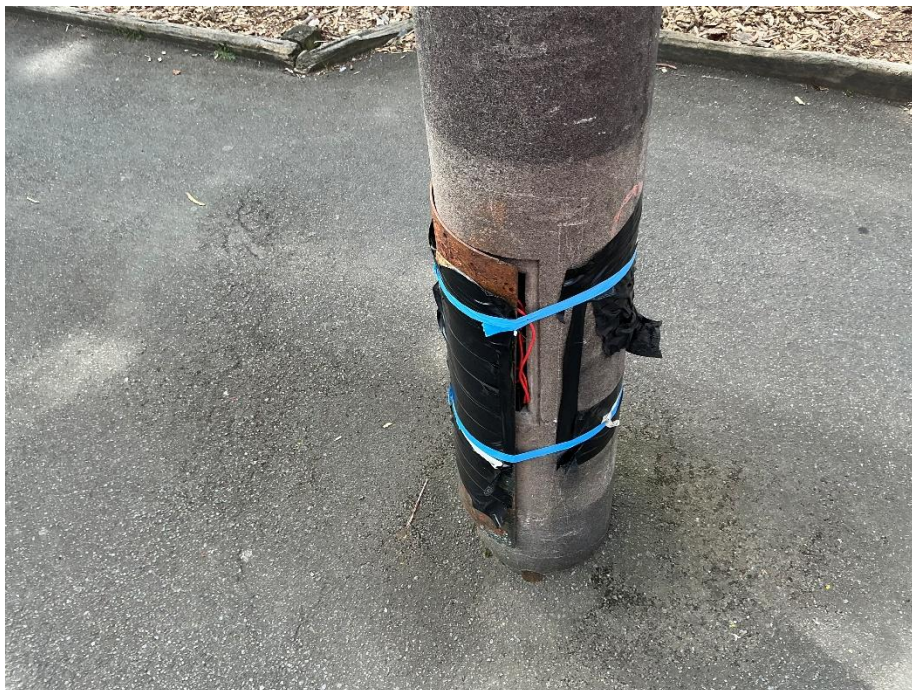
During the site visit the SAT observed that the bottom access plate to the wiring for the light pole has been poorly secured. The light pole is in close proximity to the bus stop.

Figure 5-10: View of loose wiring at base of light pole

1. Instruct the maintenance team to properly secure the cover or replace it appropriately.

Design team response	Agree – It is recommended that the identified poorly secured access plate be reported to an appropriate maintenance group for resolution.
Client safety engineer comment	Agree with Designer response. Refer to Maintenance and Renewals
Client decision	To be referred to maintenance and renewals
Action taken	To be referred to maintenance and renewals.
