# Brooklyn Hill Cycling Improvements

## Updated 90% Detailed Design Stage Safe System Audit

Prepared for:  
Wellington City Council

Prepared by:  
Stantec

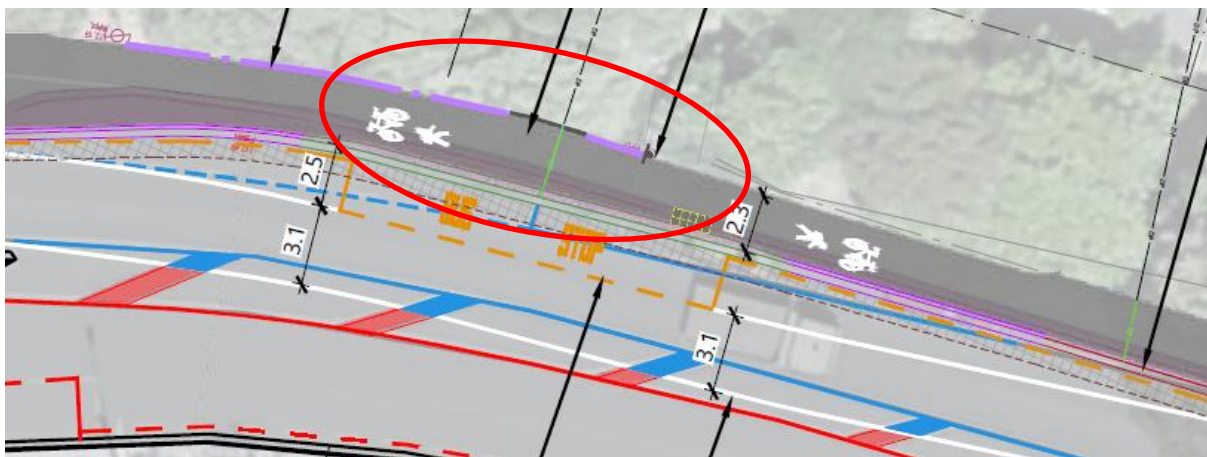
Figure 3: Drawing Sheet C303 – Shared Path by The Bus Stop west of Washington Avenue

On drawing sheet C303, a shared path for pedestrians and cyclists is shown adjacent to the bus stop west of Washington Avenue. However, the absence of the banded red surfacing to highlight potential interactions (as shown in **Figure 3**Figure 6) may reduce awareness among users. Without this visual cue, cyclists may not anticipate pedestrians entering or exiting the bus, and pedestrians may not expect cyclists passing through the shared path. Previously the SSAT has been supplied with detailed design of the shared path section, this has not been provided in this set and the SSAT would like to highlight this to ensure that the banded red surfacing is installed in this shared path section next to the bus stop at the Bidwill Street intersection.

The severity is based on reduced user awareness due to the absence of red surfacing at the shared path, increasing the risk of conflict between cyclists (particularly electric bikes travelling uphill at a faster speed) and pedestrians near the bus stop.

| Probability of a crash | Crashes resulting from this safety concern are likely. |

| Severity outcome rating | The predominant outcome of a crash resulting from this safety concern is likely to be serious. |
| Risk ranking | The safety concern is therefore deemed to be serious. |

1. Introduce banded red surfacing on the cycle path adjacent to the bus stop to warn cyclists of pedestrian activity.

| Design team response | Agreed. The banded red surfacing pavement markings can be added on the shared path adjacent to bus stop. |

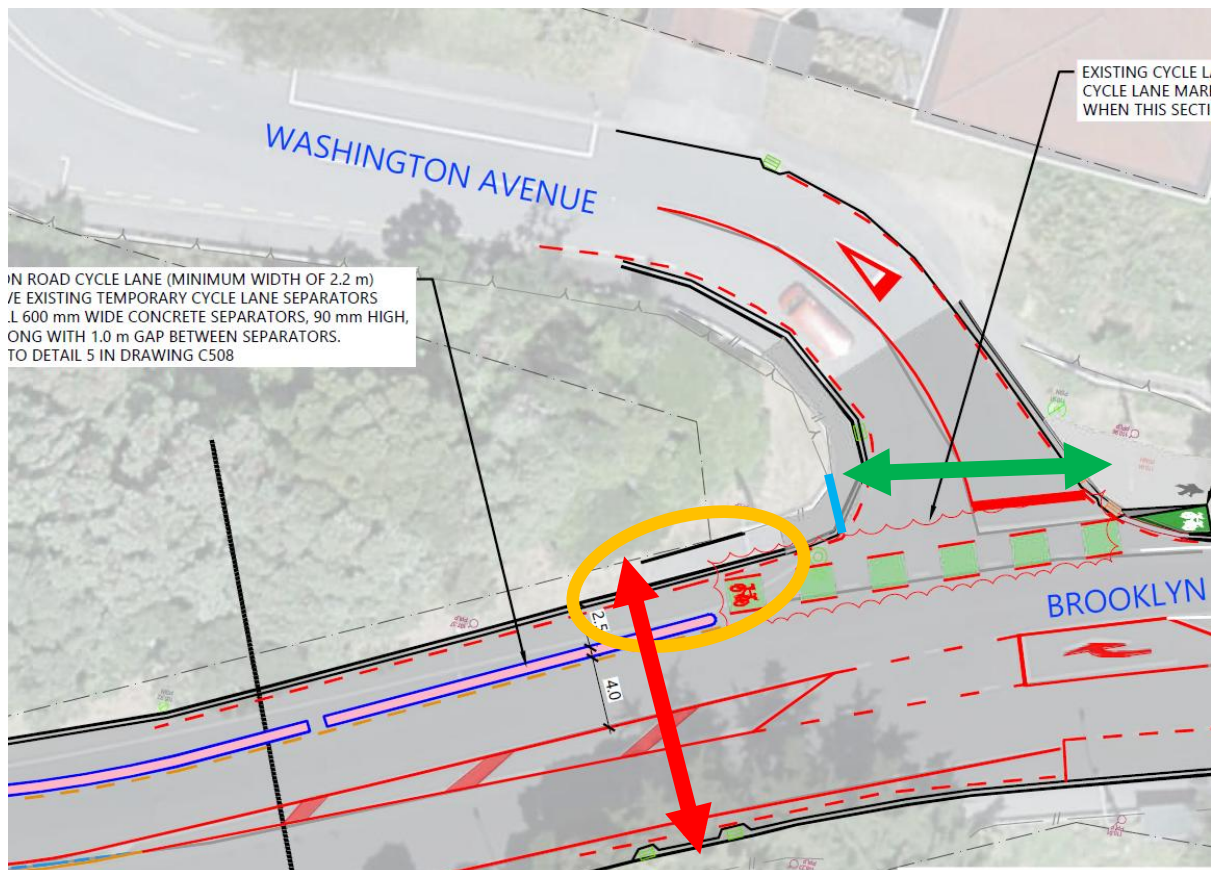
Figure 4: Drawing Sheet C303 - Pedestrian Facilities at Brooklyn Road & Washington Avenue Intersection

On drawing sheet C303, a footpath is shown southeast of the intersection between Brooklyn Road and Washington Avenue (as shown in **Figure 4**). This footpath in the orange circle could direct pedestrians to an area that is a dead end and then create a situation where they try to cross the new cycleway, separator and Brooklyn Road where the red arrow is shown. Furthermore Brooklyn Road does not have a safe median refuge in this area. This could place pedestrians in a dangerous crossing situation with tripping hazards and the lack of a pedestrian refuge.

The safer place for pedestrians to cross Washington Avenue is at the green arrow and then they can use the dedicated pedestrian crossing point with median refuge island to then cross Brooklyn Road.

However the SSAT also noticed that there are no dropped kerbs provided on the footpaths on each side of Washington Avenue and it does not appear that drawing C303 makes provision for dropped kerbs or a crossing point. This could result in pedestrians tripping when crossing Washington Avenue, furthermore it will cause difficulty for visually impaired pedestrians as well as wheelchair users to cross Washington Avenue safely in this vicinity.

The severity is based on pedestrians crossing at undesignated locations due to misleading infrastructure, increasing the likelihood of unexpected vehicle-pedestrian conflict.

| Probability of a crash | Crashes resulting from this safety concern are unlikely. |
| Severity outcome rating | The predominant outcome of a crash resulting from this safety concern is likely to be serious. |
| Risk ranking | The safety concern is therefore deemed to be significant. |

1. Install dropped kerbs on Washington Avenue to provide a crossing point for pedestrians;
2. Remove the footpath section shown in orange to prevent pedestrians becoming trapped and wanting to cross Brooklyn Road at the dead end; and
3. Consider extending the sight rail where the blue line is shown to further direct pedestrians to utilise the safer crossing point on Brooklyn Road.

| Design team response | <p>Agreed. An informal pedestrian crossing (dropped kerbs on Washington Avenue) adjacent to the cycle lane crossing can be investigated. However, the provision of such a crossing is outside the current scope of this project.</p> <p>Agreed. The section of footpath on Brooklyn Road leading to the dead end (highlighted in orange in the above image) can be removed to discourage pedestrians from becoming trapped and attempting to cross Brooklyn Road at the dead-end location.</p> <p>Agreed. A fence can be added across the footpath leading to the dead end to guide pedestrians approaching from the northern Washington Avenue footpath to cross Washington Avenue and use the safer crossing point on Brooklyn Road.</p> |
| Action taken | <p>An instruction will be issued to the designer to incorporate the required changes into the detailed design phase.</p> <p>The informal pedestrian crossing (dropped kerbs on Washington Avenue), adjacent to the cycle lane crossing, will be referred to the maintenance team for consideration as part of future maintenance planning.</p> |

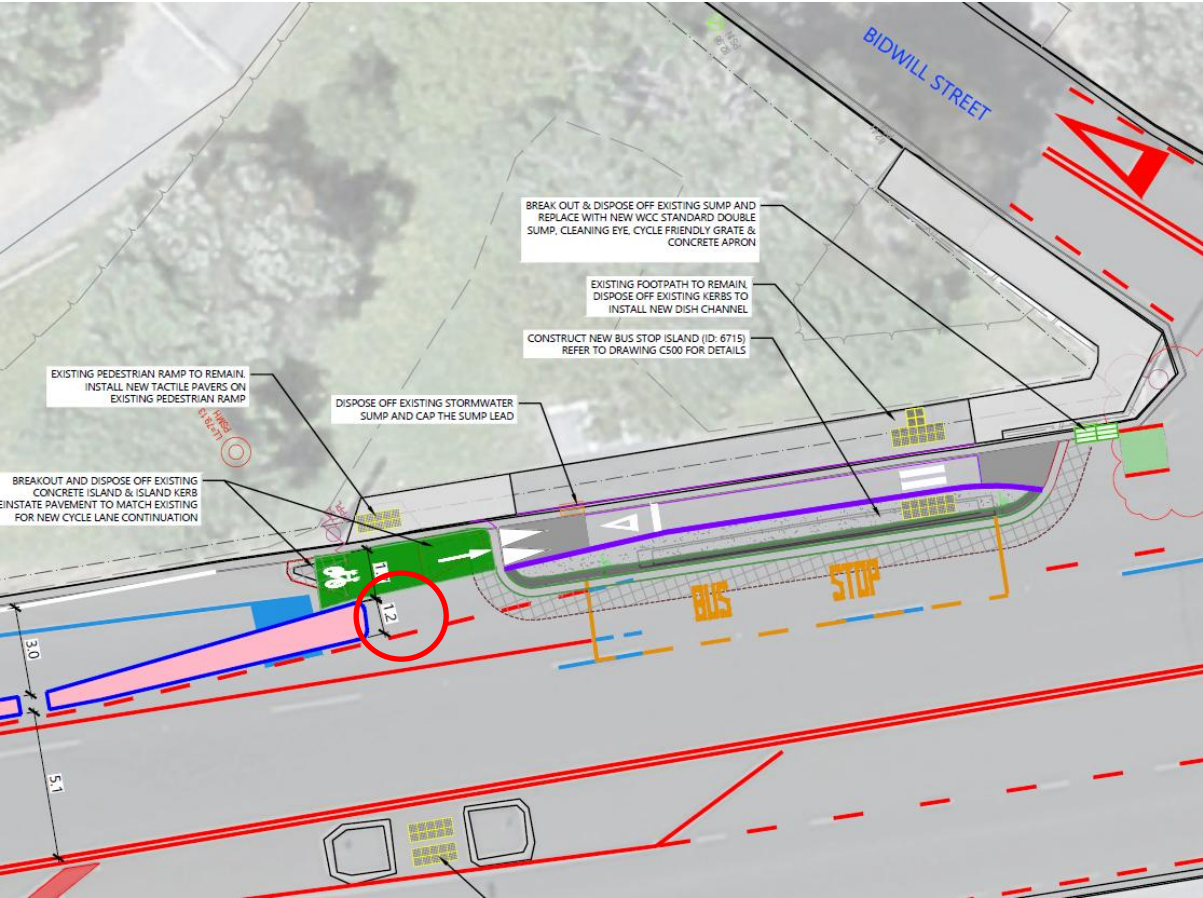
Figure 5: Drawing Sheet C302 - Missing Tactile Pavers

On drawing sheet C302, on Brooklyn Road just north of the intersection with Bidwill Street, there is a pedestrian crossing point with tactile pavers on the footpath only (as shown in **Figure 5**), once the pedestrian has crossed the cycle way there is a small refuge before the bus entry taper. Due to the distance of the crossing past a refuge island this may create ambiguity for both visually impaired pedestrians not identifying the risk of stepping into the bus entry taper zone.

The severity is based on a visually impaired pedestrian being struck by a passing bus.

| Probability of a crash | Crashes resulting from this safety concern are unlikely. |
| Severity outcome rating | The predominant outcome of a crash resulting from this safety concern is likely to be serious. |
| Risk ranking | The safety concern is therefore deemed to be significant. |

- 1. Add additional warning tactile pavers.

| Design team response | Agreed. Additional tactile pavers can be added at the location highlighted in the image above. |

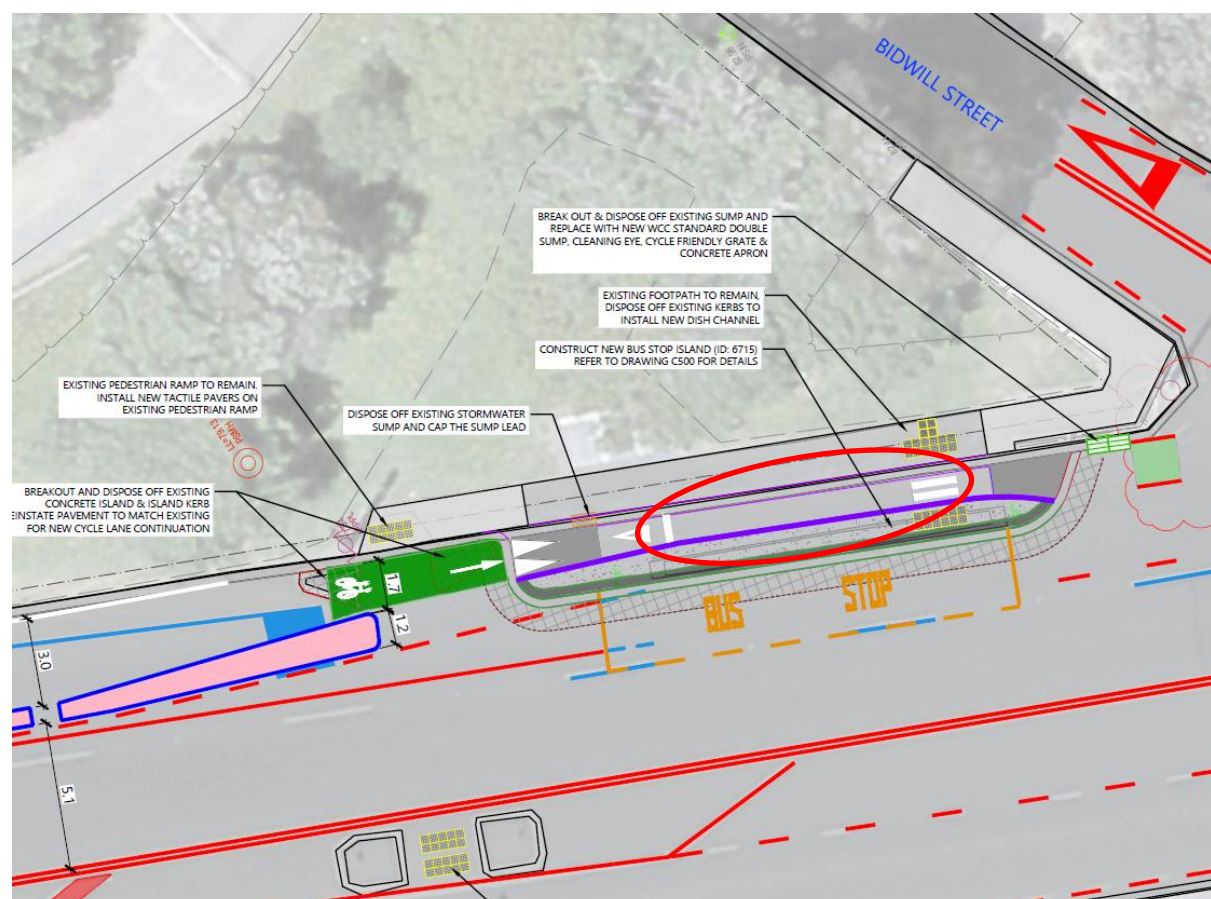
Figure 6: Drawing Sheet C302 – Shared Path by The Bus Stop north of Bidwill Street

On drawing sheet C302, a shared path for pedestrians and cyclists is shown adjacent to the bus stop north of Bidwill Street. However, the absence of red surfacing to highlight potential interactions (as shown in **Figure 6**) may reduce awareness among users. Without this visual cue, cyclists may not anticipate pedestrians entering or exiting the bus, and pedestrians may not expect cyclists passing through the shared path. Previously the SSAT has been supplied with detailed design of the shared path section, this has not been provided in this set and the SSAT would like to highlight this to ensure that the banded red surfacing is installed in this shared path section next to the bus stop at the Bidwill Street intersection.

The severity is based on reduced user awareness due to the absence of red surfacing at the shared path, increasing the risk of conflict between cyclists (particularly electric bikes travelling uphill at a faster speed) and pedestrians near the bus stop.

| Probability of a crash | Crashes resulting from this safety concern are likely. |
| Severity outcome rating | The predominant outcome of a crash resulting from this safety concern is likely to be serious. |
| Risk ranking | The safety concern is therefore deemed to be serious. |

1. Introduce banded red surfacing on the cycle path adjacent to the bus stop to warn cyclists of pedestrian activity and ensure the white crossing line is flush with the surface to prevent trip hazards.

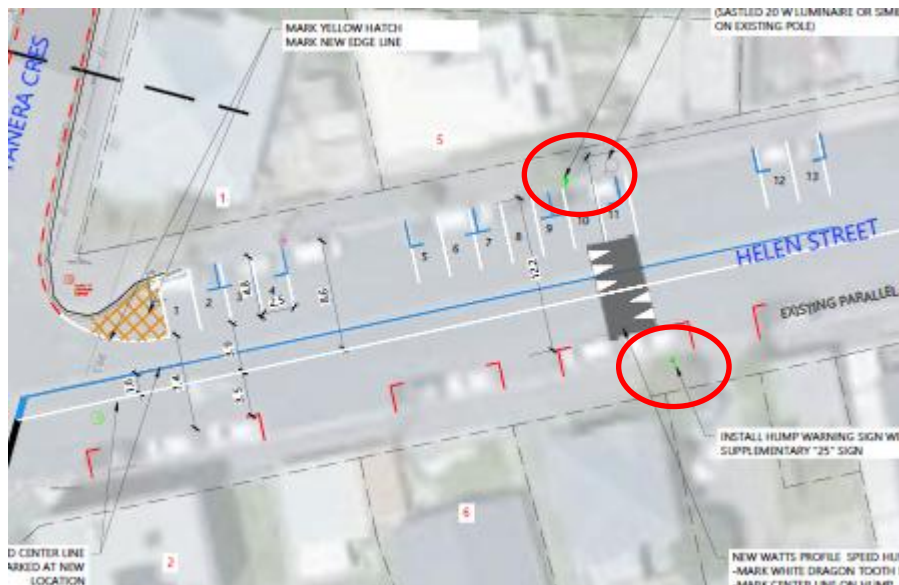
Figure 7: Drawing Sheet C306 – Speed Hump Signs next to Vegetation

Drawing sheet C306 indicates that speed hump signs are to be installed at the new humps (as shown in **Figure 7**). The signs are proposed to be placed in proximity to existing trees, if such signs are not visible to approaching drivers it could cause them to not anticipate the vertical deflection in the road and this could lead to a loss of control and potential crash.
