Wellington CBD to Miramar / Seatoun Route 2 Bus Infrastructure Improvements

Concept Stage Safe System Audit

Prepared for:
Wellington City Council

Prepared by:
Stantec New Zealand

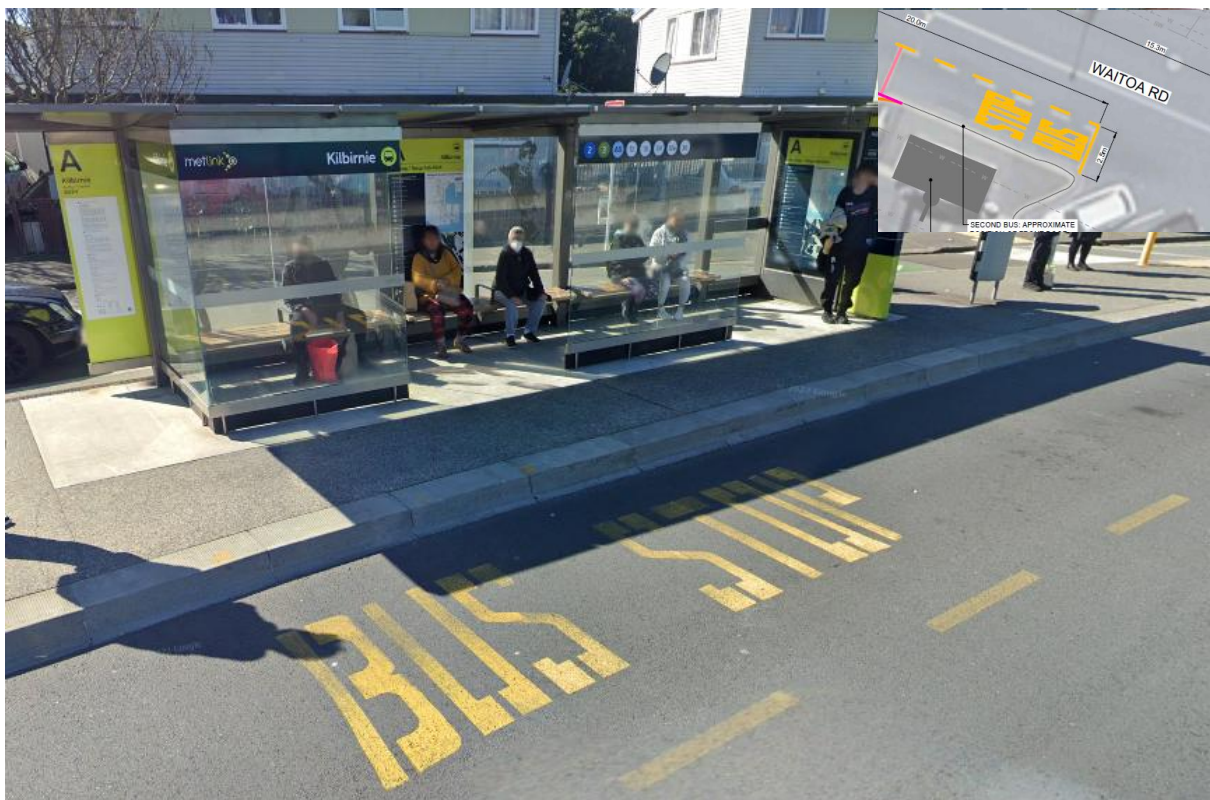
The drawings show that the bus stops are proposed to be marked with the words BUS STOP positioned parallel to the traffic lane. The existing bus stops are shown with the bus stop markings shown perpendicular to the traffic lane. It is important to ensure that a consistent approach to the implementation of these markings is taken in line with the NZTA recommendations (copied below).

It is noted that, as an example, at the Kilbirnie Bus Interchange the bus stop markings have been implemented perpendicular to the traffic lane.

Figure 5-1: Existing BUS STOP markings at a Kilbirnie bus stop marked perpendicular to the roadway. INSET proposed bus stop markings on a bus stop in Hataitai.

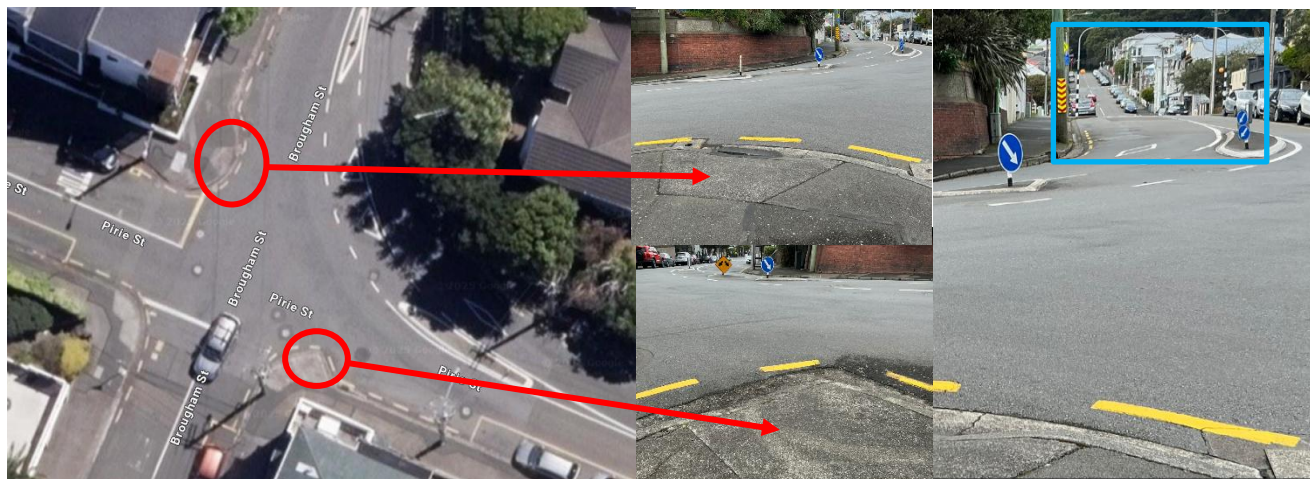
Figure 5-2: Pedestrian drop kerbs (cut downs) that should be removed.

It is noted that there is a pedestrian crossing on Pirie Street located to the east of this intersection (refer to Figure 5-2 above, far right – blue rectangle) that pedestrians wishing to cross at this location could safely use instead.

Therefore, it is recommended that the existing pedestrian drop kerbs (cut downs) on the opposing corners of Pirie Street and Brougham Street respectively are removed.

Design team response	<p>We agree with the SSAT that both pedestrian drop kerbs indicated in Figure 5.2 should be removed (noting that the cutdowns across the give-way and stop-controlled legs of Brougham Street and Pirie Street should remain).</p> <p>The SSAT has noted that there is an existing zebra crossing on Pirie Street to the east of the intersection. While this crossing will provide a safe crossing opportunity for some pedestrians in this area, it will only serve pedestrians that are coming to/from the eastern leg of Pirie Street (ex. it won't be used by pedestrians travelling north-south on Brougham Street). We believe that this intersection does not currently provide sufficiently safe crossing opportunities for pedestrians, and removing the drop kerbs and traffic islands will only make it less safe to cross.</p>
----------------------	---

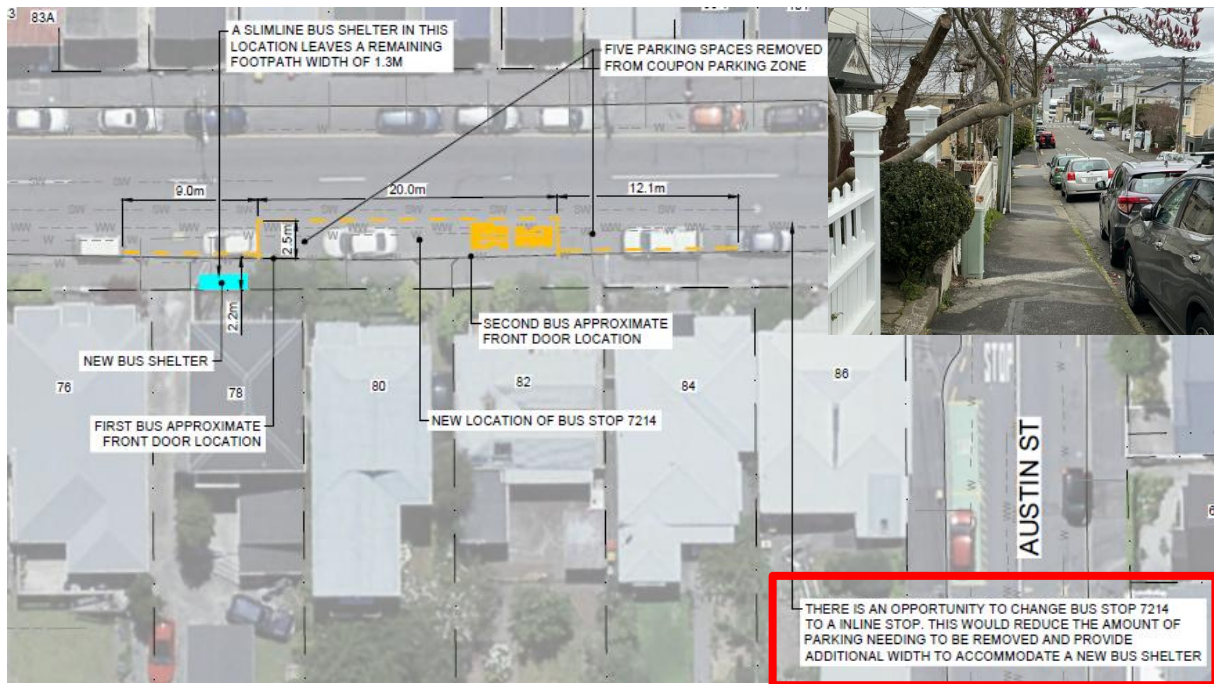
The proposed provision of a slimline bus shelter outside #78 Pirie Street at the new location for Bus Stop 7214 results in the available remaining footpath width being 1.3m as noted by the designers. This creates issues for mobility impaired pedestrians negotiating their way past the shelter on the footpath.

Figure 5-3: Relocated Bus Stop 7214 proposed design. INSET: Existing footpath width – view west.

Design team response	We agree with the SSAT’s finding and recommendation. An alternative option would be to retain this stop in its existing position, where a building canopy provides shelter for waiting passengers without reducing the footpath width.
Client safety engineer comment	Consider both options and provide a recommendation.
Client decision	Due to budget constraints, bus route efficiency, and a change in level of service, the design should retain existing bus stops.

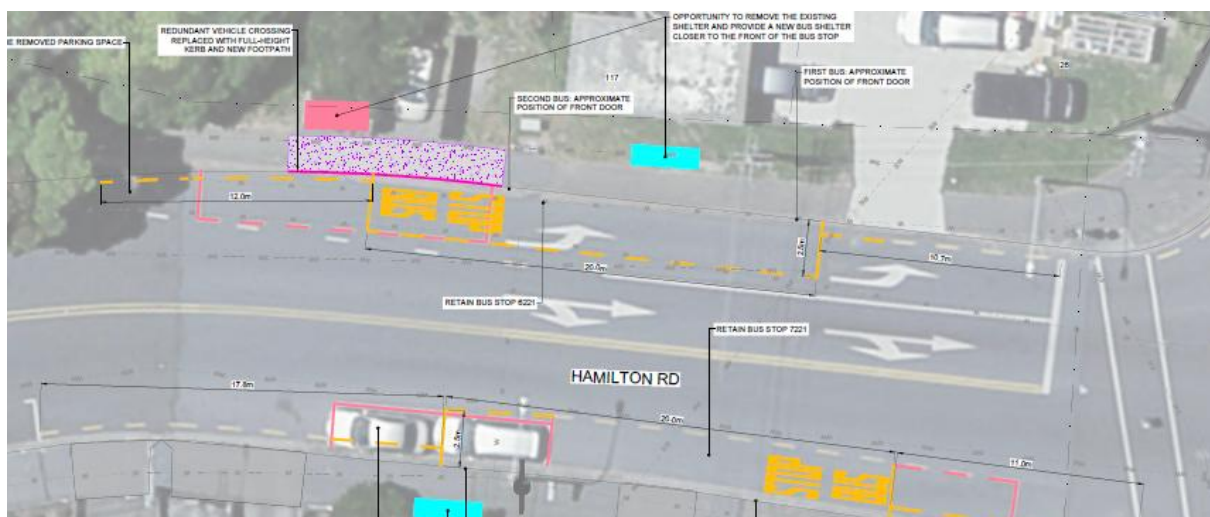
Figure 5-4: View of Bus Stop 6221 on Hamilton Road approach to SH1 (Wellington Road)

The SSAT consider that the designers should review the lane configuration on this approach to the intersection with a view to altering the left lane to accommodate straight ahead and left turn movements, leaving the right lane for right turn movements only. This would have the advantage of the bus driver being able to proceed straight ahead from the bus stop into the (now) straight ahead / left turn lane in order to continue south on Kilbirnie Crescent towards Kilbirnie.

The new lane arrow markings should also be provided on the approach to the bus stop to ensure approaching motorists are aware of the lane configuration when a bus is at the bus stop.

Design team response	<p>1. We agree with the SSAT's finding and agree that altering the lane configuration as they've proposed is a potential option. However, before confirming a change to the lane configuration, we recommend undertaking an investigation of the turning movements at the intersection to assess how a change to the lane configuration would impact vehicle delays.</p> <p>2. We agree with the SSAT.</p>
Client safety engineer comment	Agre with Designer's responses.
Client decision	Agree with responses and comments. An investigation and review of the impacts will be undertaken within this project.
Action taken	Do not make any changes to the lane allocation as shown in TR drawings. Alternative solutions to this stop to be proposed in next stage of design.

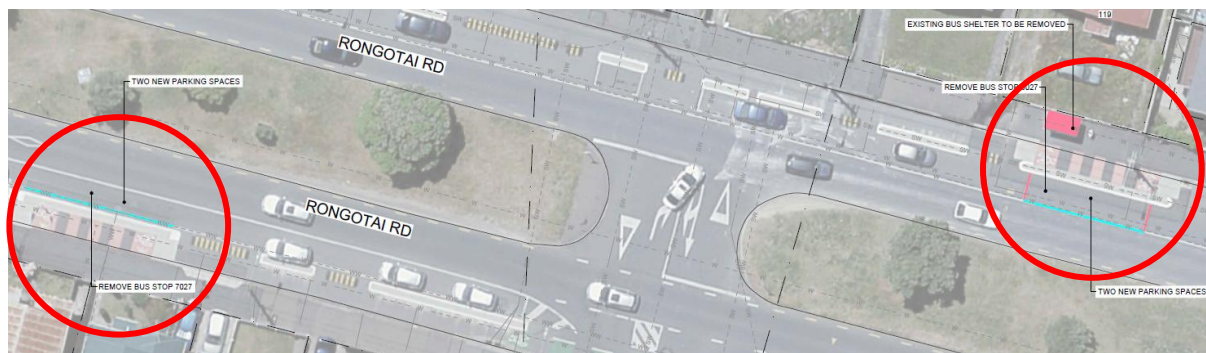
There are two existing bus stops on Rongotai Road that are proposed to be removed. These are bus stops 6027 and 7027. Both of these bus stops have a cycle lane positioned between the footpath and the bus stop, which is flush with the adjacent surfaces and as such incorporates the red warning surfacing as shown in Figure 5-5 below.

As the bus stops are to be removed and replaced with standard parking spaces, there now no need to require cyclists to slow down and prepare to stop for bus passengers. As such it is recommended that the red surfacing on the cycle lanes at these two locations be replaced with green surfacing. This would confirm to cyclists that they no longer need to be concerned with bus passengers and serve to remind any pedestrians utilising the new parking spaces at this location to be aware of the potential for cyclists on the adjacent cycle lane.

Figure 5-5: Rongotai Road cycle lanes with red surfacing adjacent to bus stops to be removed.

1. Replace the red surfacing within the cycle lanes at the removed bus stops with green surfacing.

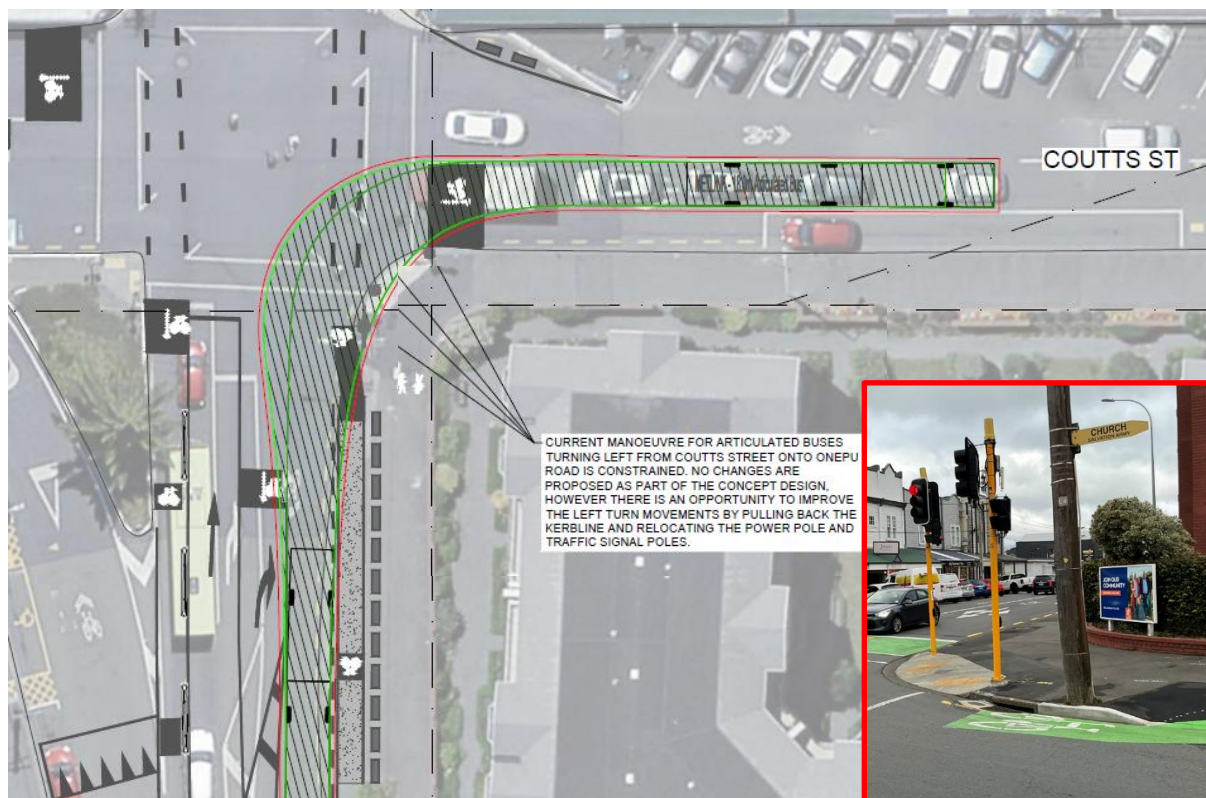
It is noted that this issue has been identified by the designers as per the note on the drawing.

Figure 5-6: Swept path of longer articulated “bendy” bus left turn into Onepu Road from Coutts St showing overrun of existing kerb and adjacent utility poles (power and traffic signal).
INSET: View of south-east corner of intersection with traffic signal poles and power pole.

Design team response	We agree with the SSAT’s finding and recommendation to relocate the power pole and traffic signal poles. Another option that has been considered is to pull back the limit lines on the southern leg of Onepu Road. However, we note that the existing limit line for the right turn bay is already located significantly far back from the intersection (approximately 13m) and space to the south is constrained to be able to provide sufficient stacking length. An alternative option could be to combine the
----------------------	--

through and right turn lanes into one shared lane, noting that an assessment should be done to confirm the impact on vehicle delays.
Client safety engineer comment	Further assessment and a recommendation required.
Client decision	Agree with responses and comments. An investigation and review of the impacts will be undertaken. Review design of limit line being pulled back.
Action taken	WCC to instruct design engineer to investigate impacts on vehicle delays, and tracking.

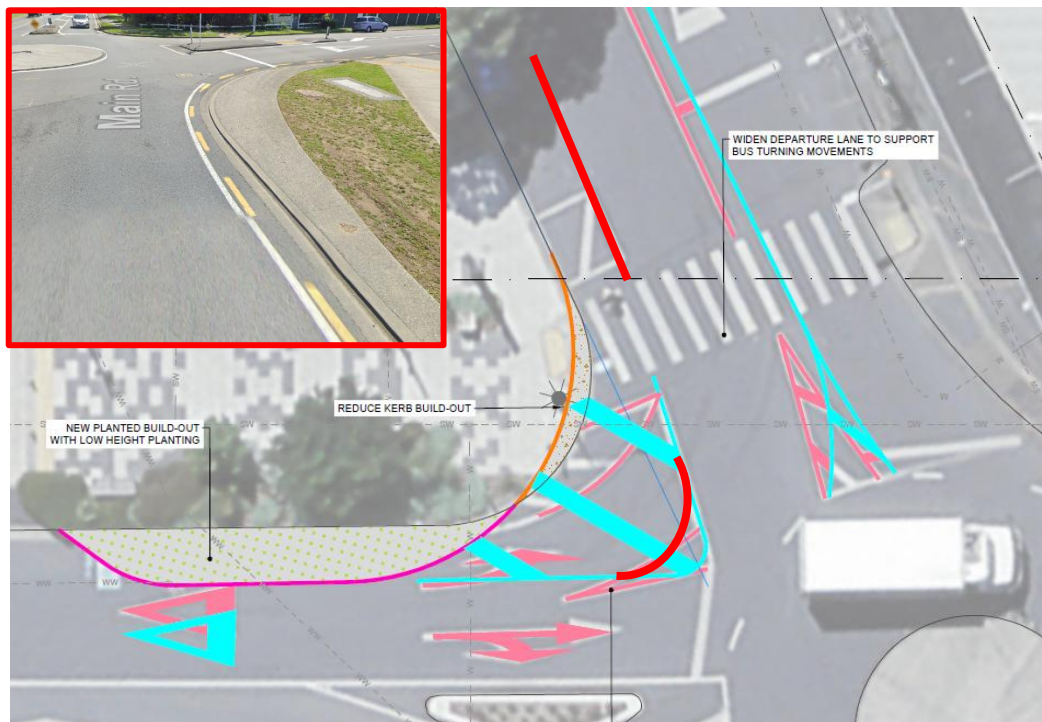
The proposed adjustments for the left turn movement from Miramar Avenue into Park Road are shown in Figure 5-7 below. It is noted that the left turn movement is such that left turning vehicles will have no option but to track across the proposed hatched road markings. Additionally, there is no edgeline guidance for motorists beyond the existing pedestrian crossing, to ensure that they are guided past the parked vehicle space to the north.

Furthermore, by providing such a large left flush island there is a risk of light vehicle drivers deciding to shortcut the roundabout by tracking over the flush island. In turn creating an acute angle towards the western side of the zebra crossing, resulting in an increased risk of drivers looking right (towards the roundabout) and not seeing a pedestrian on the pedestrian zebra crossing until they are upon it. The provision of a mountable kerbside island under the flush road markings should be considered. This will force the majority of left turning drivers to proceed to the roundabout and after navigating that intersection orient their vehicles perpendicular to the pedestrian zebra crossing, thus providing improved sight lines towards any pedestrians crossing from the western side. Larger vehicles, such as buses will be able to track over the mountable island to accommodate their vehicle swept path.

Figure 5-7: Proposed road markings / intersection adjustments at Miramar Avenue / Park Road.
INSET: Example of raised apron at roundabout in Tawa with mountable kerb.

Design team response	<p>1. We agree with the SSAT’s recommendation to alter the hatched shoulder marking. The shoulder design will be finalised during detailed design based on tracking envelopes for left-turning vehicles.</p> <p>2. We agree with the SSAT’s recommendation to provide a mountable apron. We do note that consideration will need to be given to ensuring that there is clear separation between the apron and the footpath to ensure that there is a clear separation between the road and the pedestrians space.</p> <p>3. We agree with the SSAT’s recommendation to add an edgeline on Park Road. We recommend that, in addition to the edgeline, hatched shoulder markings are included so it is clear that this is not a separate traffic lane.</p>
Client safety engineer comment	Agree with Designer’s responses.
Client decision	Agree with responses and comments. Complete shoulder marking, include a mountable apron, add edgeline, and include hatched shoulder marking in detailed design.

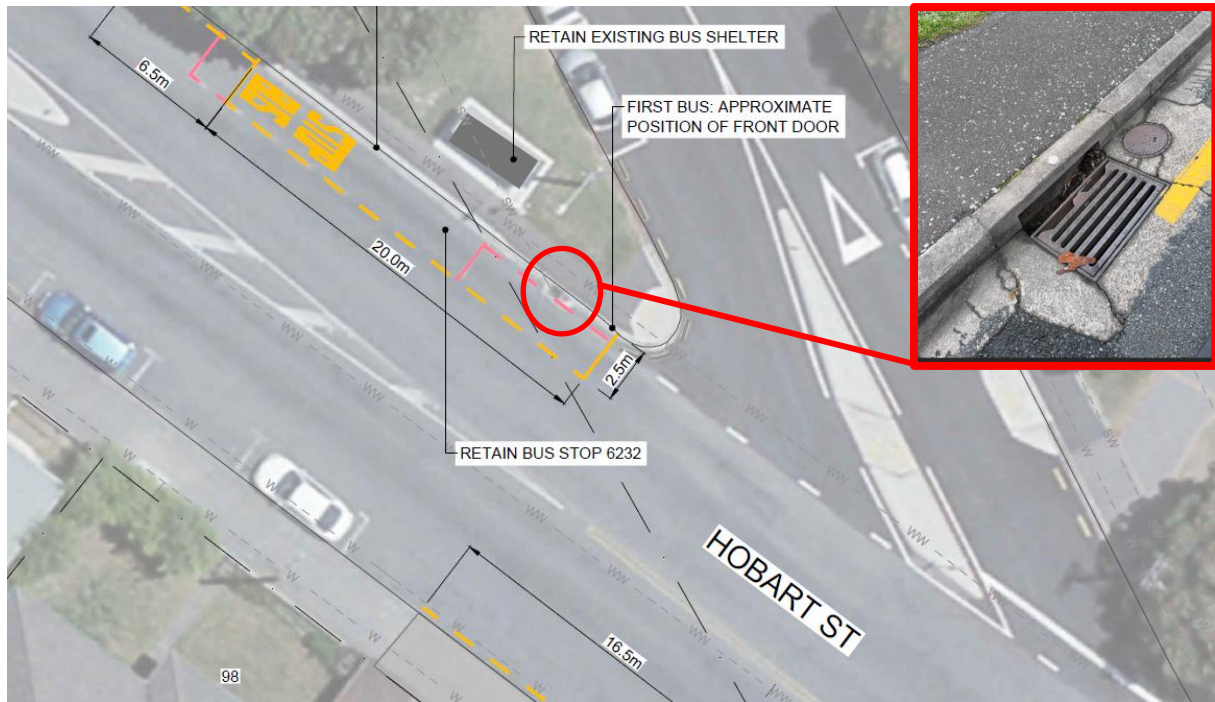
Figure 5-8: View of existing bus stop 6232 on Hobart St with non-cycle friendly grate (see INSET).

given to changing the drainage grate to a cycle friendly grate in advance of the proposed transitional cycleway changes.

1. Replace the existing drainage grate with a cycle friendly grate.

Design team response	This item is out of scope of the Route 2 Bus Infrastructure improvements project. However, we do agree with the SSAT finding and recommend that replacement of this grate is added to WCC's schedule of maintenance works.
Client safety engineer comment	Agree with Designer's response.
Client decision	Agree with responses and comments. Replace existing grate with cycle friendly grate.

Action taken	Direct designers to replace existing with a cycle friendly grate in the design drawings.
--------------	--

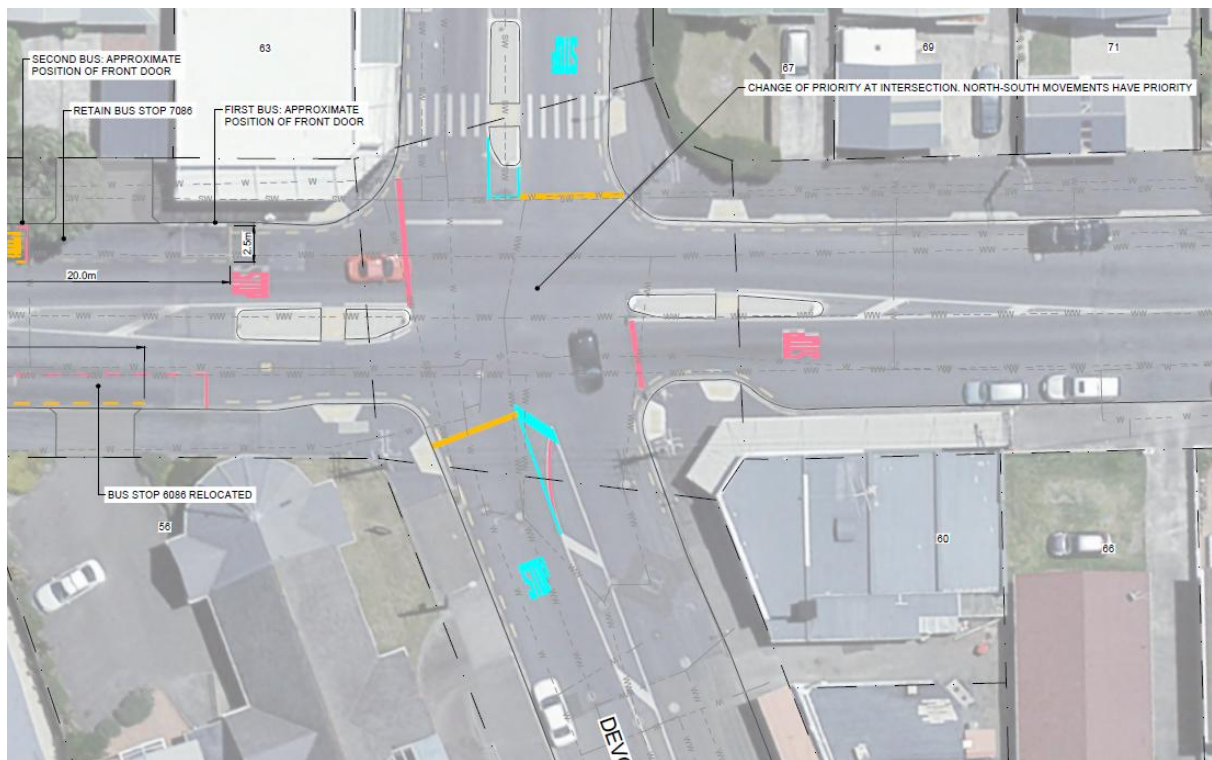
The intersection of Devonshire / Caledonia / Hobart is proposed to be altered so that Hobart Street has priority (refer to Figure 5-9 below). The drawings indicate a change in the road markings but do not indicate any proposed changes to the signage on each approach.

The existing gated STOP signs present on the respective Hobart Street approaches will need to be relocated to the Devonshire Road and Caledonia Street approaches. It is noted that there is no central island on the Devonshire Road approach to accommodate a secondary STOP sign. Given that this is a change to an existing intersection, particularly care needs to be taken to ensure that it is clear to motorists on the approaches that previously had the right of way that they are now required to give way.

Figure 5-9: Proposed priority changes at Devonshire / Caledonia / Hobart intersection.

Design team response	<p>1. We agree with the SSAT’s recommendation. Signage has not been detailed at the concept design stage. The full extent of signage works will be shown at the detailed design stage. We would also recommend installing temporary “New Road Layout” signage at the intersection to warn drivers of the change in priority.</p> <p>2. We agree with the SSAT’s recommendation. Providing a median traffic island on Devonshire Road would also improve safety for pedestrians crossing Devonshire Road by provide a crossing refuge. The existing flush median is approximately 2.5m wide, which provides suitable width to install a refuge island.</p>
Client safety engineer comment	Agree with Designer’s responses.
Client decision	Agree with responses and comments. In the detailed design, provide signage detail and median traffic island on Devonshire Rd.
Action taken	Direct the designers to include in detailed design drawings, signage detail and median traffic island on Devonshire Rd.

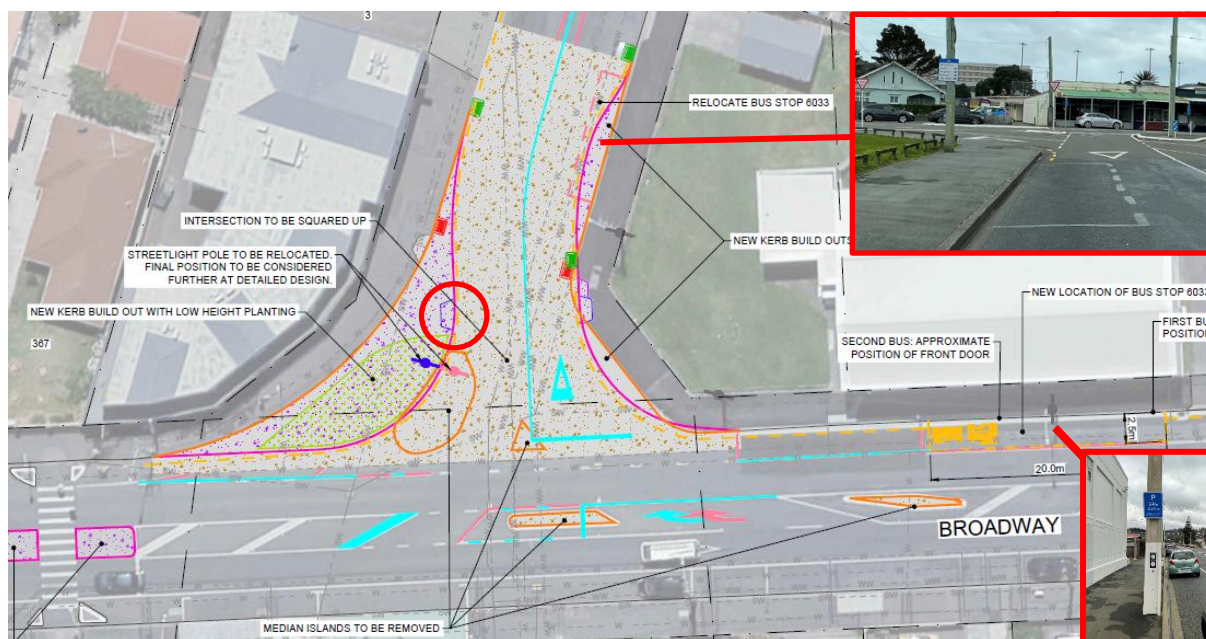
It was noted on site that the outbound bus stop on Hobart Street at Broadway has already been relocated back to the original location (refer to INSET (top) in Figure 5-10 below) on Broadway. This temporary bus stop location on Hobart Street was only in place while construction work to the church was underway in 2022. The bus stop on Broadway will have a large power pole (refer to INSET (bottom) in Figure 5-10 below) located in the middle of the bus stop. As this bus stop is the closest one to the Wellington Airport (excluding the more expensive Airport Express (AX) Bus Route), there is likely to be bus passengers alighting with luggage. Designers to satisfy themselves that the rear door on a longer articulated “bendy” bus will not be blocked by the power pole and impacting the egress of bus passengers.

Figure 5-10: Proposed changes to Hobart Street / Broadway intersection. INSET (top): Hobart St approach to Broadway, note the already removed bus stop. INSET (bottom): Existing power pole at location of relocated bus stop.

Design team response	<p>1. We agree with the SSAT’s recommendation. Tactile pavers have not been included as part of the concept designs; they will be included at the detailed design stage.</p> <p>2. The back door of an articulated bus is located 10.5m to 12.5m from the front of the bus. The pole is located approximately 9.5m from the front of the bus stop. If a bus is aligned properly with the front of the stop, the power pole will not obstruct any doors. However, there is a risk of conflict if a bus stops further forward than the front of the stop.</p>
----------------------	---

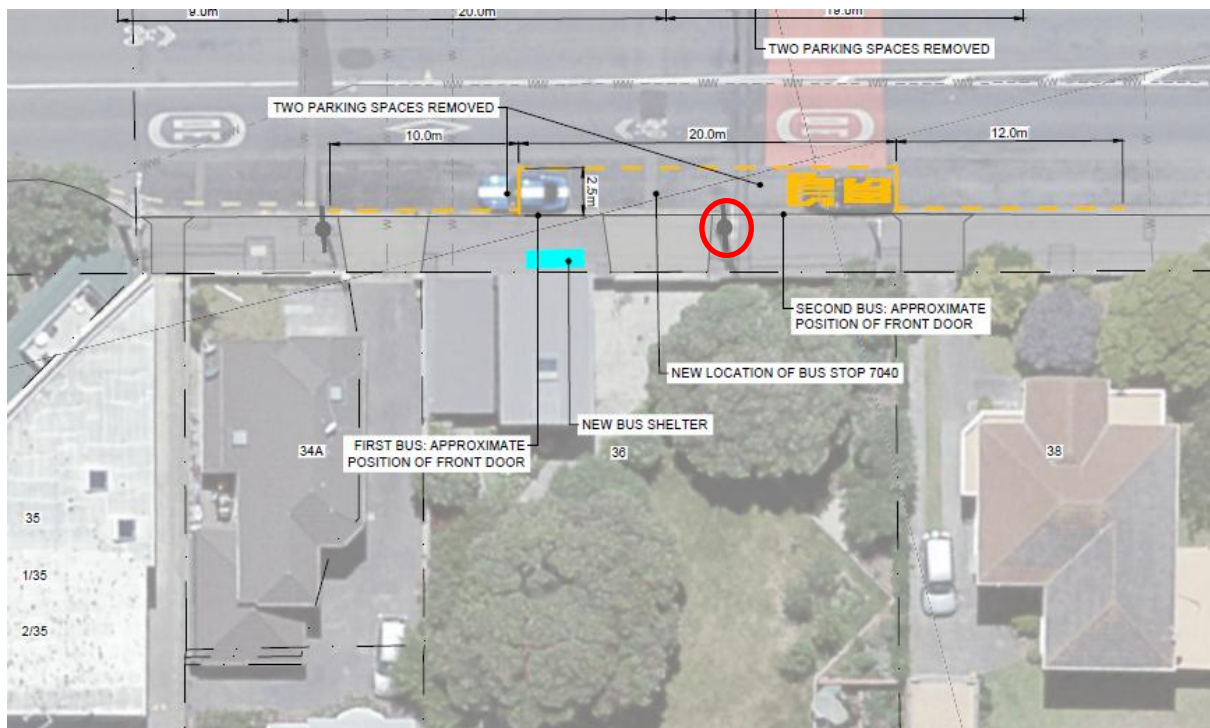
The relocated inbound bus stop 7040 located on the Dundas Street approach to Falkirk Avenue has been positioned such that there is an existing power pole present in the middle of the bus stop on the footpath. There is the potential for the rear door on a longer articulated “bendy” bus to be blocked by the presence of the power pole affecting the ability of passengers to exit the bus from the rear door.

It is likely that this bus stop is well utilised given its proximity to the local supermarket located on the south-east corner of the intersection.

Figure 5-11: Relocated inbound bus stop 7040 on Dundas Street prior to Falkirk Avenue. Note the power pole (circled in red) located midway along the bus stop.

Design team response	The back door of an articulated bus is located 10.5m to 12.5m from the front of the bus. The pole is located approximately 11m from the front of the proposed bus stop location. We recommend that the bus stop is moved east by approximately 1m, which can be accommodated without affecting the accessibility of the front door of the first or the second bus, and the front of the stop would still be located at the proposed bus shelter location.
Client safety engineer comment	Agree with Designer’s response and recommendation.
Client decision	Agree with responses and comments. Move bus stop east 1m.
Action taken	Direct designers to move bus stop east 1m in Traffic Resolution drawings.

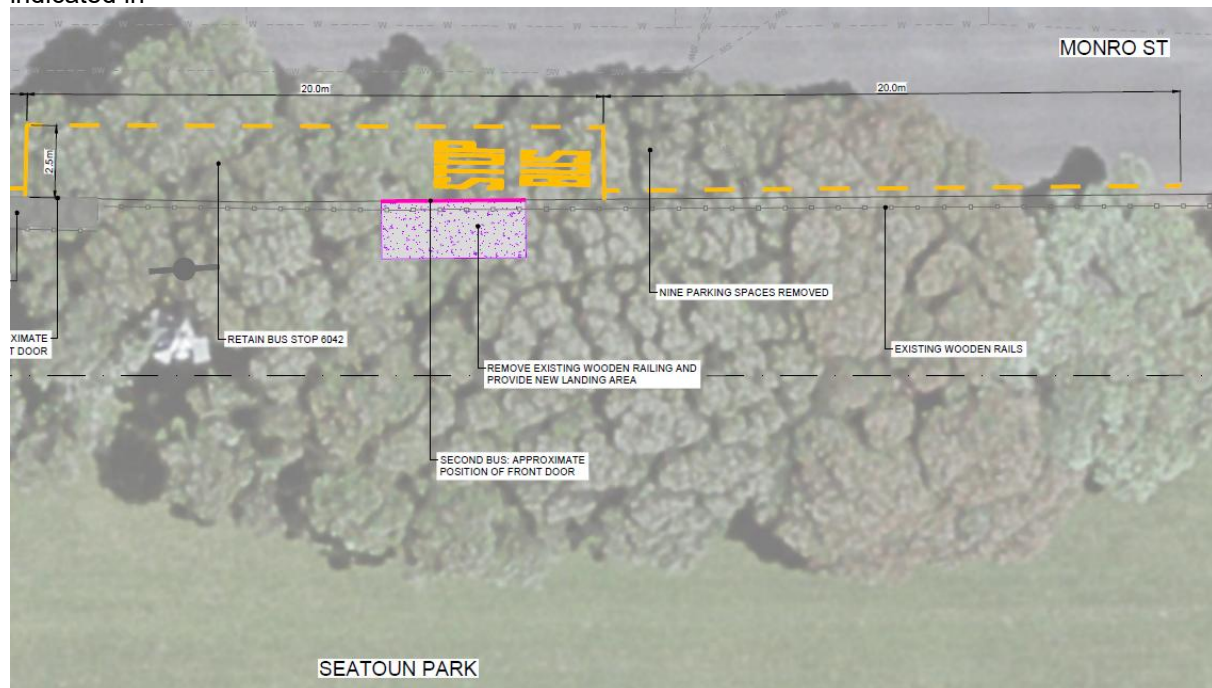
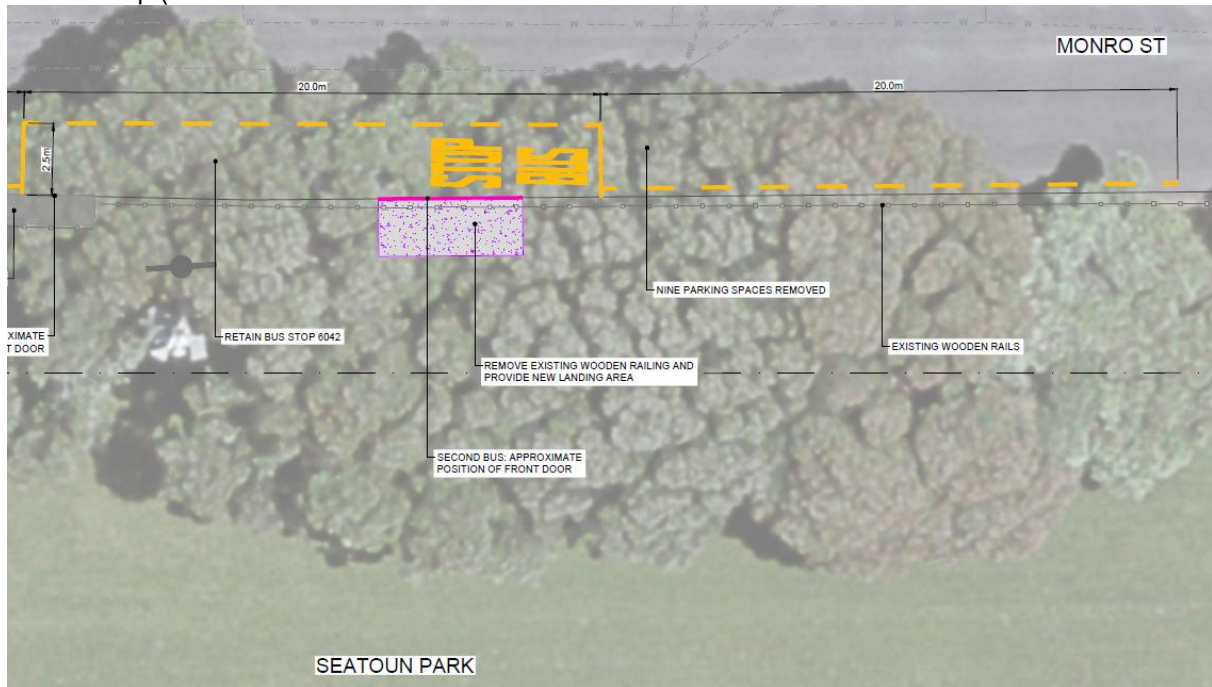
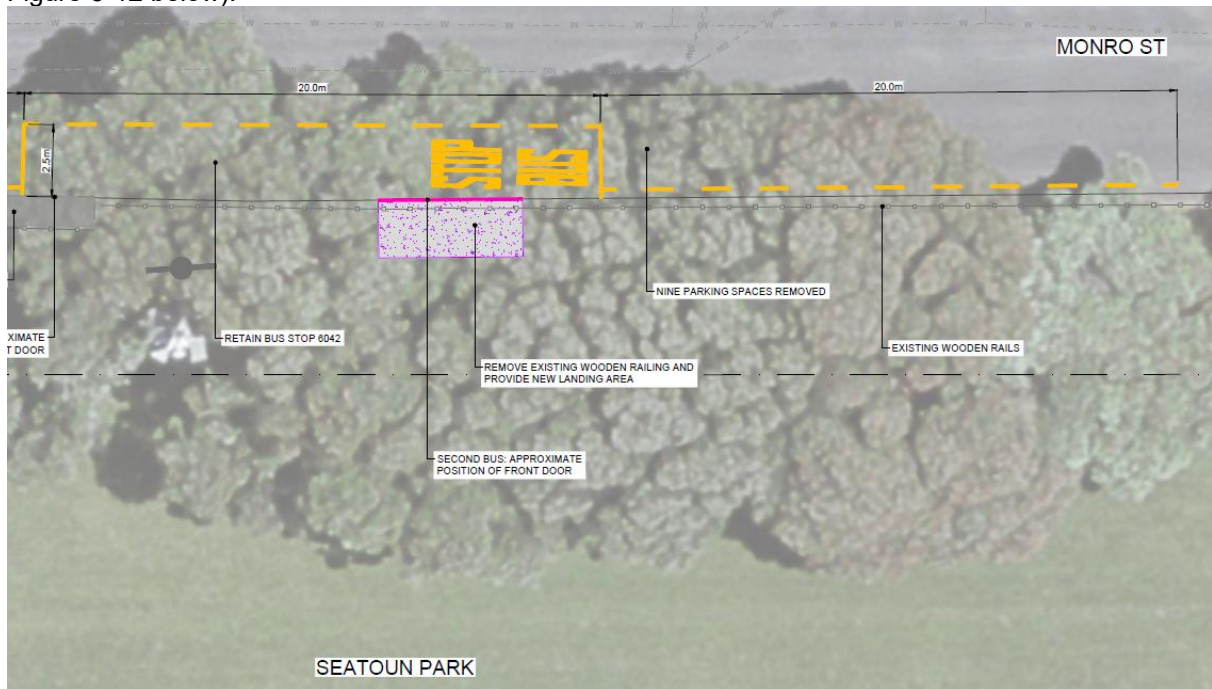
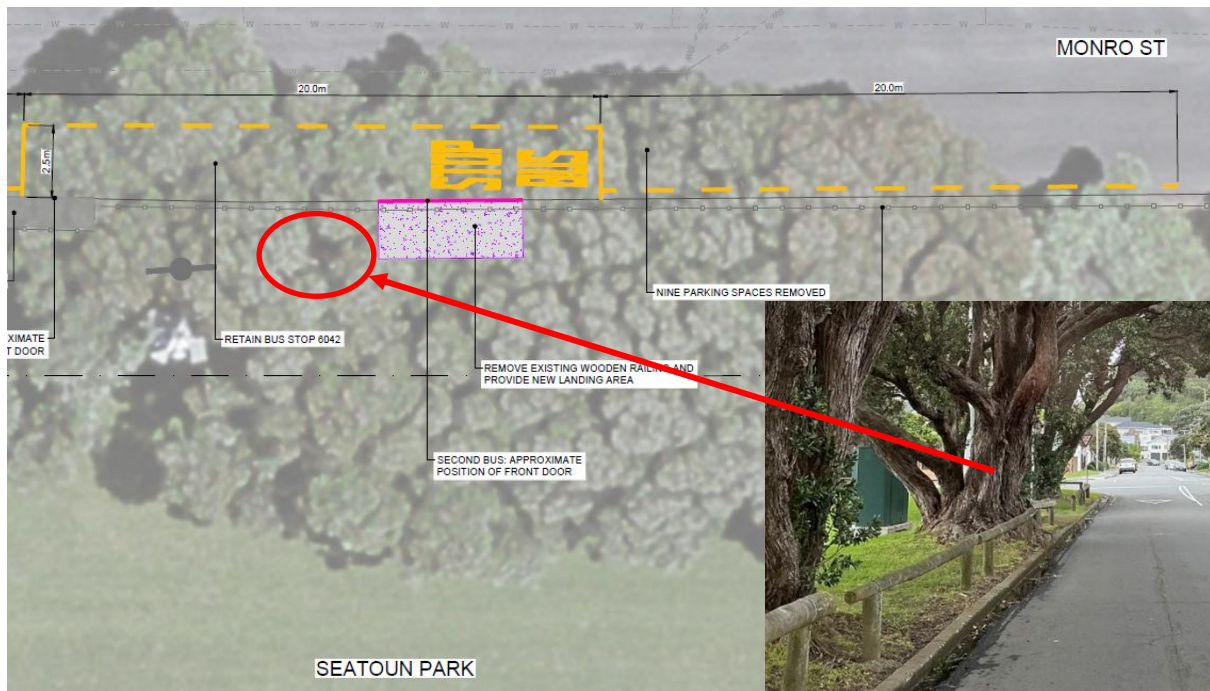
The existing bus stop 6042 on Monro Street is proposed to have a new landing area provided as indicated in

Figure 5-12 below. There are large Pohutukawa trees located along the edge of Seatoun Park and one is positioned directly in front of where the landing is proposed. It is not clear whether the rear door(s) on a longer articulated “bendy” bus would be clear of the large Pohutukawa tree located within

the bus stop (refer to the INSET in

Figure 5-12: Proposed layout of bus stop 6042 on Monroe Street. INSET: View of bus stop showing large pohutukawa tree potentially blocking the rear door(s) of a longer articulated “bendy” bus.
