Wadestown Shops cycleway audit – safety and accessibility

90% design audit

Paneke Pōneke
Bike network plan

July 2023

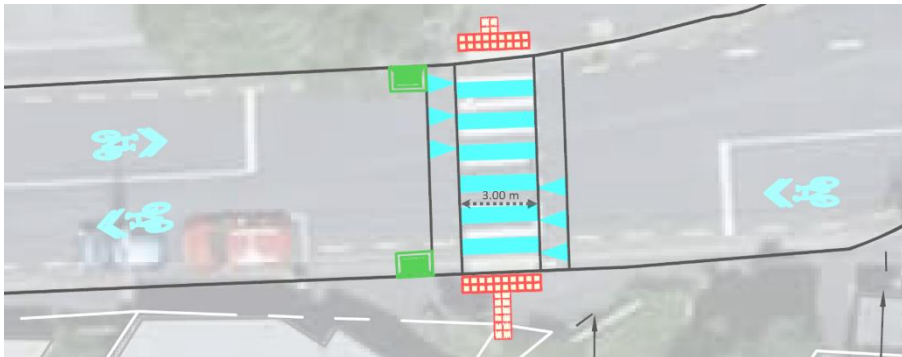
Figure 4: example of a raised platform width on the route.

To be an effective and safe system-compliant speed-calming device, a raised crossing should be at least 100 mm high, in which case it should also have a 6 m wide tabletop so that long vehicles (e.g., buses) always have at least one set of wheels on the crossing; otherwise, they may bottom out. This may result in unnecessary damage to the road, trucks, and public transport vehicles.

If the crossing platform is less than 100 mm high, the width requirement stated above is less important, but also unlikely to result in a meaningful reduction in traffic speed.

Probability of crash occurring	N/A
Expected crash severity	N/A
Primary treatment recommendations:	
3.2.1	N/A
Supporting treatment recommendations:	
3.2.2	Make platforms 6 m wide on bus routes.
3.2.3	Design crossings to be 75 mm high on bus routes and 100 mm in other areas (as discussed in Kilbirnie audit)

Designer	<p>We agree with CAT recommendation 3.2.2 and will update the designs accordingly. This also reflects feedback from the bus reviewers for the Berhampore to Newtown transitional cycleway.</p> <p>Both of these crossings are on a bus route so will be designed 75mm high in alignment with CAT recommendation 3.2.3</p>
-----------------	---

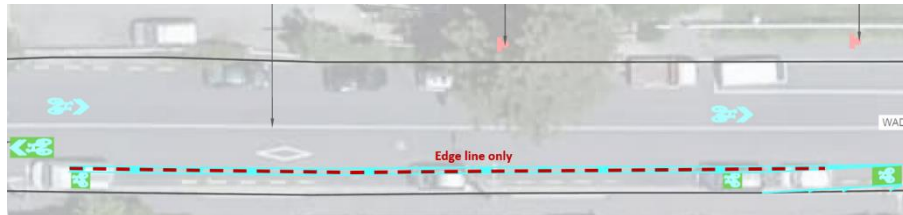
Figure 5: Area without physical separations and only buffered edge line

The safety issue is the risk of drivers driving onto the cycle lane and hitting cyclists (Figure 5 and Figure 6). This risk is increased by the narrow width of traffic lanes and lack of centreline in some places.

The crash type expected are side swipe and rear end crashes between motor vehicles and riders. The risk factors include medium traffic volume exposure (4,000 to 6,000 vpd) and the operating speed of vehicles (35-39 km/h) which is above the tolerable impact speed for a crash between vehicles and cyclists/ electric scooter riders.

Probability of crash occurring	Unlikely
Expected crash severity	Serious injury
Primary treatment recommendations:	
3.3.1	Provide vertical separation along cycle lanes.
Supporting treatment recommendations:	
3.3.2	Provide buffered cycle lanes.
3.3.3	Designer to consider an advisory shoulder, also known as a 2-1 'two minus one' lane layout. This is a single lane with shoulders on either side for cyclists and e-scooter riders in urban areas. This would require considerable consultation with all road users to improve its acceptance and operation.

Responses:	
Designer	<p>Vertical separation and/or buffers were considered for this section but unable to fit between the kerb to kerb width for the full length considering other constraints and requirements (including retaining parking in the Wadestown Town centre as instructed by WCC).</p> <p>Whilst we accept the problem as described, we do not agree with CAT recommendation 3.3.3. With volumes up to 6,000 vehicles per day and a winding alignment that restricts forward visibility, we would assess that a 2 minus 1 alignment would increase the risk of drivers swerving into the shoulder area / cycle lane without checking for cyclists to avoid oncoming vehicles. We also note that where this option was proposed on the Ngaio transitional project it did not proceed due to technical advice from WCC and Waka Kotahi and public opposition.</p> <p>No change is proposed unless directed otherwise by the client decision</p>

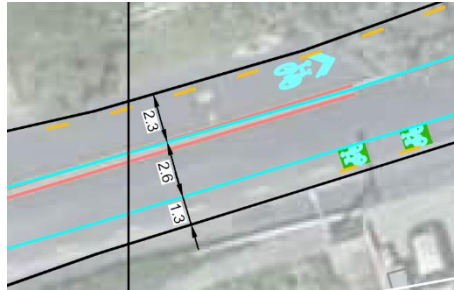
Figure 7: #134 – narrow lanes – no yellow centreline

The risk factors include medium traffic volume exposure (3,000 vpd) and the operating speed of vehicles (40-44 km/h) which is above the tolerable impact speed for a crash between vehicles and cyclists/ electric scooter riders or vehicles and other vehicles.

The relevant standards include Waka Kotahi’s CNG ([Mixed traffic lanes](#)).

Probability of crash occurring	Likely
Expected crash severity	Minor injury
Primary treatment recommendations:	
3.4.1	Where legal and absolute minimum lane widths cannot be achieved on a cross-section, provide traffic calming.
Supporting treatment recommendations:

3.4.2	Designer to provide the suitable lane widths. The absolute (legal) minimum traffic lane width is 2.5 m.
3.4.3	Designer to consider an advisory shoulder, also known as a 2-1 'two minus one' lane layout. This is a single lane with shoulders on either side for cyclists and e-scooter riders in urban areas.

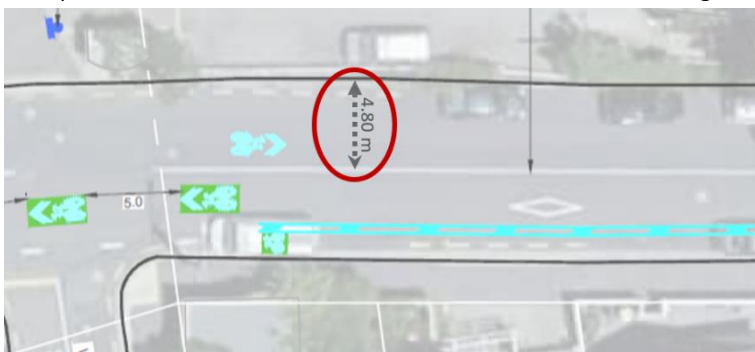
Figure 8: #107 example of wide mixed lane.

achieve the target safe speed of 30 km/h. As described in section 3.13, the risk is greater in the uphill direction where the speed differential between riders and motorised vehicles is greater.

The TCD manual part 5 gives guidance for [shared lanes](#). In general, they should be 4.2 m or greater (for side-by-side cyclists and motor vehicles) or no wider than 3.0 m (for single-file cyclists and motor vehicles, where buses are not present).

Probability of crash occurring		Unlikely
Expected crash severity		Serious injury
Primary treatment recommendations:		
3.5.1	N/A	
Supporting treatment recommendations:		
3.5.2	That all car parking spaces are marked to narrow the mixed traffic lane.	
3.5.3	Ensure mixed traffic widths are less than 3.2 m or more than 4.2 m to avoid drivers overtaking riders.	
3.5.4	Remove parking spaces where there is insufficient space.	
3.5.5	Mark parking lanes / spaces only where parking is permissible.

Designer	We agree with the CAT recommendations 3.5.2, 3.5.4 and 3.5.5 and will mark the parking spaces accordingly We also agree with CAT recommendation 3.5.3 and will review the lane width as part of the next design iteration.
Safety Engineer	Agree with CAT and Designer’s response.
Client decision	Agree with all four recommendations.
Action taken	Amend designs to marking parking and traffic lanes as advised.

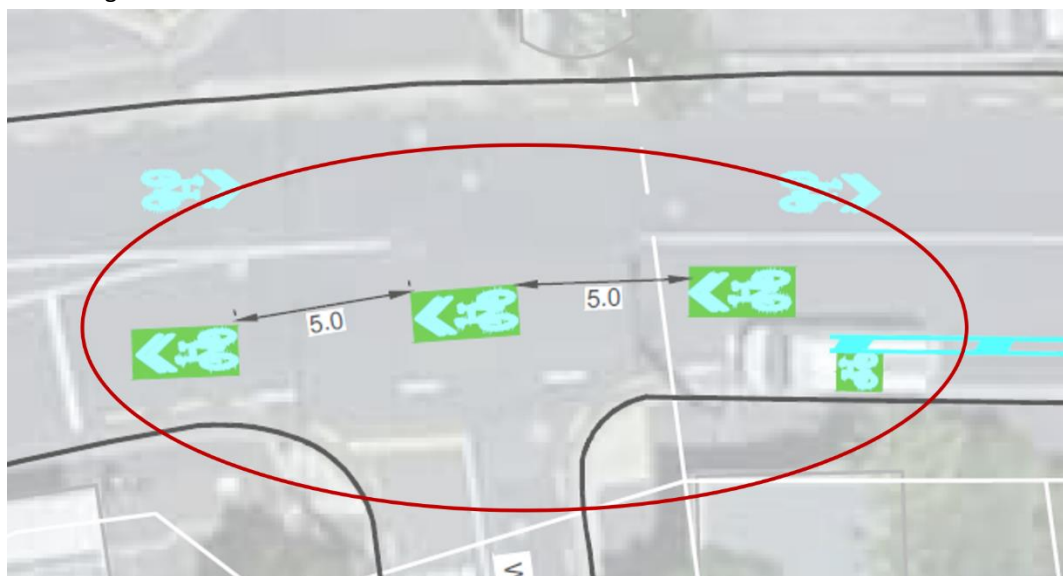
Figure 10: sharrow markings don't guide riders to take the lane

The risk factors include medium to high traffic volume exposure (5,000 to 8,000 vpd) and the operating speed of vehicles (35-39 km/h) is above the tolerable impact speed for a crash between vehicles and cyclists/ electric scooters.

There is currently no guidance for transitioning sharrows from the kerbside to the live lane, however, the markings should be intuitive for all road users.

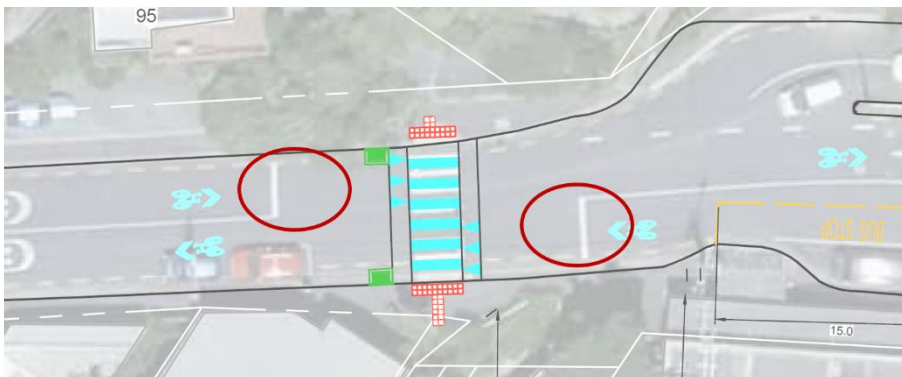
Figure 11: example where no ASBs are provided

There is no facility for cyclists to wait ahead of traffic at the zebra crossing at Fancourt Street. This creates a potential safety issue where drivers may not be aware of riders alongside as they move off across the zebra crossing.

Relevant standards are Waka Kotahi’s CNG (wait facilities at intersection) and [Buffered Advanced Stop Box](#) guidance note.

Probability of crash occurring	N/A
Expected crash severity	N/A
Primary treatment recommendations:	
3.7.1	N/A
Supporting treatment recommendations:	
3.7.2	Provide Advanced Stop Boxes at limit lines for cyclists in mixed traffic lanes. Note that this issue recurs throughout the design.

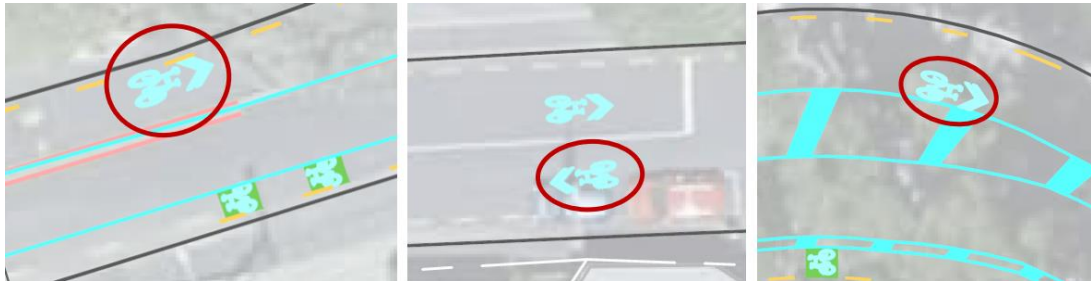
Figure 12: Examples of poor sharrows placement.

The issue is cyclists not taking the lane correctly locating themselves in the lane as indicated by the sharrows placement.

The relevant standards are Waka Kotahi’s sharrows marking best practice guidance note and the CNG (mixed traffic lanes).

Probability of crash occurring	N/A
Expected crash severity	N/A
Primary treatment recommendations:	
3.8.1	N/A.
Supporting treatment recommendations:	
3.8.2	Ensure sharrows are placed correctly to encourage cyclists to take the centre of the lane.

Designer	We agree with the CAT recommendation, and the sharrows locations will be updated prior to the next drawing issue
Safety Engineer	Agree with CAT and Designer’s response.
Client decision	Agree with everyone.
Action taken	Sharrows to be updated in next drawing set.

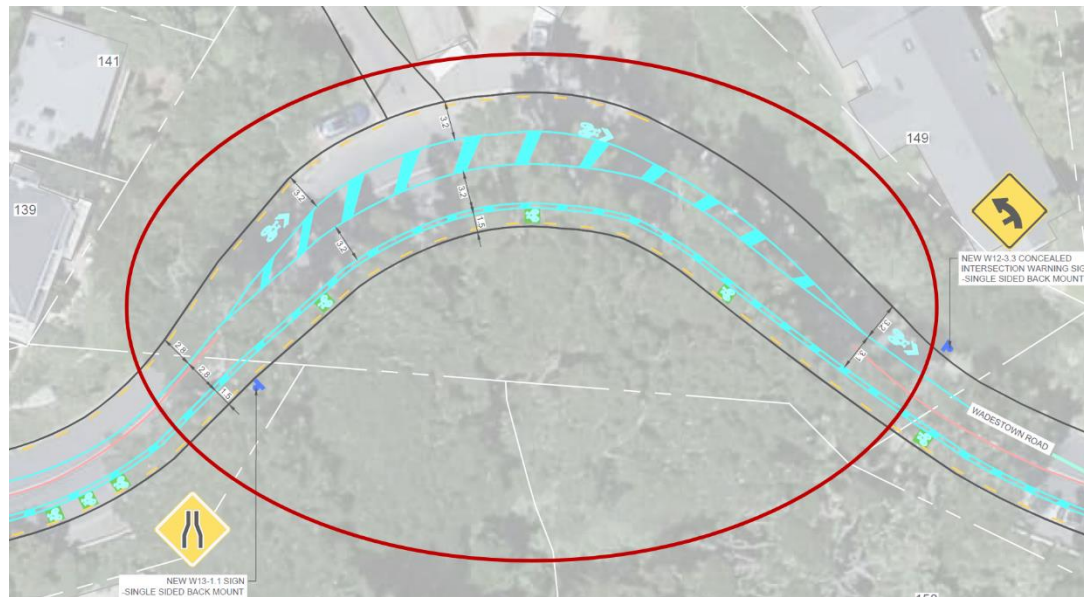
Figure 13: #142-158 example of cycle Lane on inside of curve

Motorists cutting the corner into the cycle lane will be a frequent occurrence, but the low volumes of cyclists and fact that most motorists will adjust their course if a cyclist is present, means crashes are unlikely. The CAT assume that overtaking drivers can utilise the flush median when negotiating this curve.

The risk factors include medium traffic volume exposure (4,200 VPD) and the operating speed of vehicles (35-39 km/h) which is above the tolerable impact speed for a crash between vehicles and cyclists/ electric scooter riders. The greatest risk would be long heavy vehicles, and especially those with trailers, tracking close to the kerb with their rear wheels.

Probability of crash occurring	Unlikely
Expected crash severity	Serious injury
Primary treatment recommendations:	
3.9.1	Provide vertical separation within the buffer on the inside of curves.
Supporting treatment recommendations:	
3.9.2	N/A

Responses:	
Designer	We agree with the CAT recommendation, and this will be reviewed, and the design updated subject to vehicle tracking requirements prior to the next drawing issue
Safety Engineer	Agree with CAT and Designer’s response.
Client decision	Agree with all of the above.
Action taken	Review and add separators on the corner, subject to bus tracking.

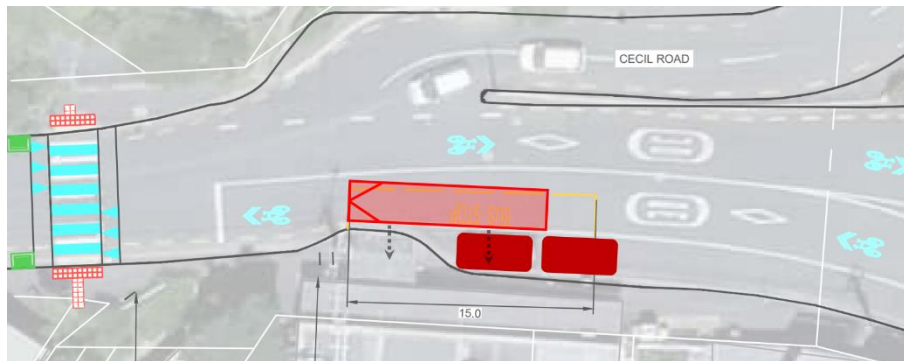
Figure 14: #100 Bus stop outside adjacent kerbside parking.

The risk factors include medium to high traffic volume exposure (6,000 VPD) but the operating speed of vehicles will be reduced with the RSP, to the tolerable impact speed for a crash between vehicles and vulnerable road users.

The relevant standards include the [Public transport design guidance](#).

Probability of crash occurring	Unlikely
Expected crash severity	Non-injury
Primary treatment recommendations:	
3.11.1	Remove the kerbside parking.
Supporting treatment recommendations:	
3.11.2	Consider extending the kerb buildout towards the RSP to provide a bus border and retain the kerbside parking.
3.11.3	Consider relocation of the bus stop.

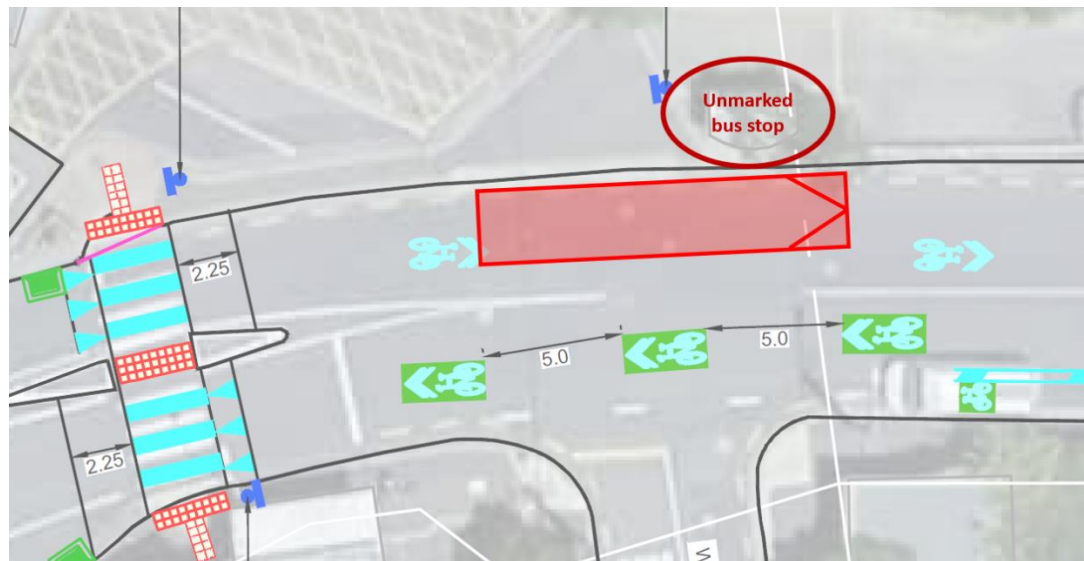
Figure 15: #100 unmarked bus stop

The safety issue is unfamiliar motorists and riders not anticipating buses stopping at an unmarked bus stop. This could also cause passing attempts by drivers and or riders when it may be unsafe.

The risk factors include medium traffic volume exposure (5,000 VPD) but the operating speed of vehicles will be reduced with the RSP, to the tolerable impact speed for a crash between vehicles and vulnerable road users.

3.12.2 Mark the bus stop as per guidance.

Designer	We agree with the CAT recommendation, and this will be implemented as part of the next drawing issue
Safety Engineer	Agree with CAT and Designer’s response.
Client decision	Agree.
Action taken	Mark on the bus stop in the next set of drawings.

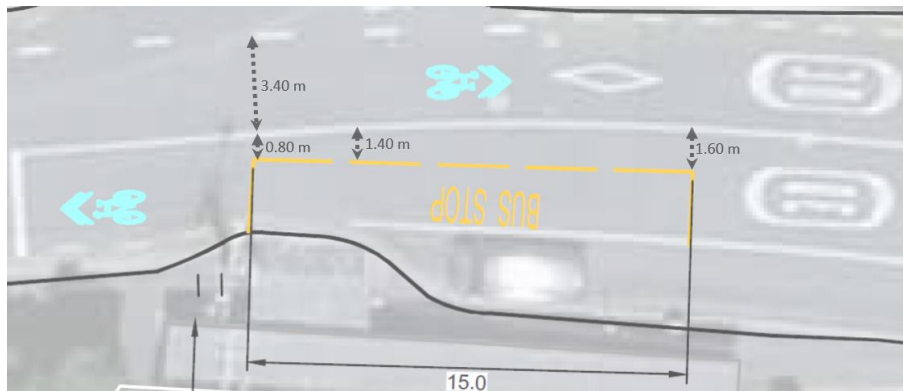
Figure 19: Lane width past in lane bus stop

The crash type expected is a side swipe crash between riders, buses, and other vehicles.

The risk factors include medium to high traffic volume exposure (6,000 VPD) but the operating speed of vehicles will be reduced with the RSP, to the tolerable impact speed for a crash between vehicles and vulnerable road users.

Probability of crash occurring	Unlikely
Expected crash severity	Non-injury
Primary treatment recommendations:	
3.15.1	N/A
Supporting treatment recommendations:	
3.15.2	See 3.11.2 and 3.11.3.
3.15.3	Ensure the eventual narrow width is clear to uphill riders when a bus is present.

Responses:	
Designer	We agree with the CAT recommendation, and this will be reviewed prior to the next drawing issue to provide a consistent width between the bus stop and centre line
Safety Engineer	Agree with CAT and Designer’s response.
Client decision	Agree with the above.
Action taken	Centreline to be adjusted in the next set of drawings.
