## Bunny Street

Developed design stage

Safe system audit

Report prepared for  
**Wellington City Council**  
September 2025

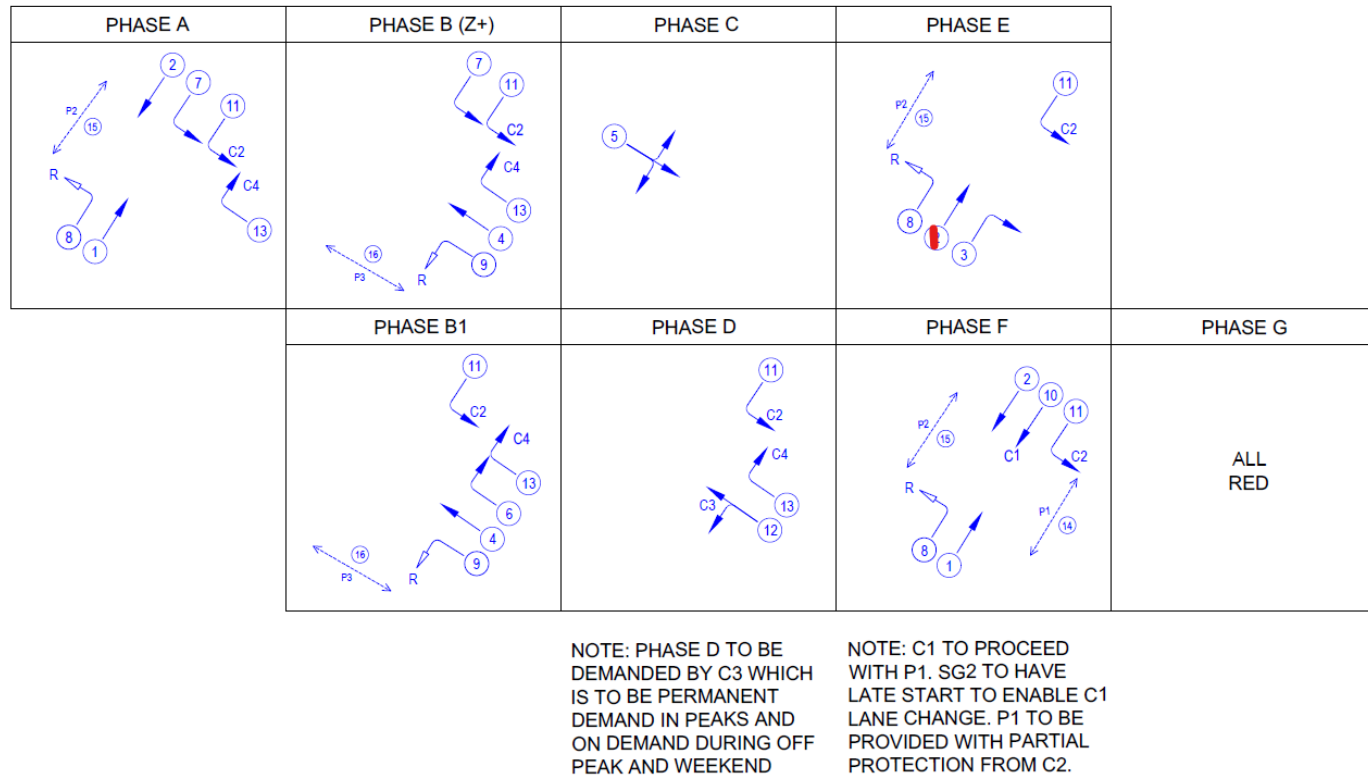
**Figure 3-2: Bunny / Featherston / Thorndon signal phasing (note SG 1 label corrected in phase E)**

| <p>The safety issue is that cyclists entering the road from the Bunny Street cycleway approach might think the signals for the cycleway bend (SG 13 – see Figure 3-2) in the primary position (i.e. at the limit line) apply to them, and proceed during the wrong phase.</p> <p>The crash type expected is cyclist vs motor vehicle – depending on the phasing, the latter could be travelling at speeds likely to cause serious injury to a cyclist.</p> <p>The risk factors include:</p> <ul style="list-style-type: none"> <li>Both columns of cycle signals (“standard” i.e. non-directional, and right turn) are located directly to the left of the cycleway approach lane for road-entering cyclists – meaning the signal column immediately adjacent to these cyclists is in fact the signal column for the cyclists continuing around the cycleway bend.</li> <li>Potential for primary cycle signals to be mounted at lower height, thus potentially visible to waiting cyclists.</li> <li>General lack of familiarity with directional cycle signals / multiple cycle signal columns for a signal approach.</li> <li>People react to change – even if they understand the difference between the two cycle signals, road-entering cyclists may make a false start when they see SG 13 go green.</li> <li>Compounding effects with other issues discussed in issues 3.1.3 and 3.1.4</li> </ul> | Expected crash severity | Serious injury |

| <p>The safety issue is that cyclists travelling around the cycleway bend originating from Bunny Street (movement C4 / signal group 13) may get fed up with the stop-start nature of this movement, and progress in a phase when they have a red light.</p> <p>Under the proposed phasing (Figure 3-2):</p> <ul style="list-style-type: none"> <li>Phase A – C4 can go</li> <li>Phase B – C4 can go</li> <li>Phase C – C4 red light (presumably to avoid conflict with cyclists coming from Bunny St west approach and entering the cycleway)</li> <li>Phase D – C4 can go</li> <li>Phase E – C4 red light (to avoid conflict with cyclists coming from the Thorndon Quay cycleway approach and progressing through the intersection)</li> <li>Phase F – C4 red light (to avoid conflict with crossing pedestrians)</li> </ul> <p>I.e. there are three times in a cycle where C4 cyclists are expected to stop, of which only one (Phase F) is probably warranted.</p> | Probability of crash occurring | Unlikely |

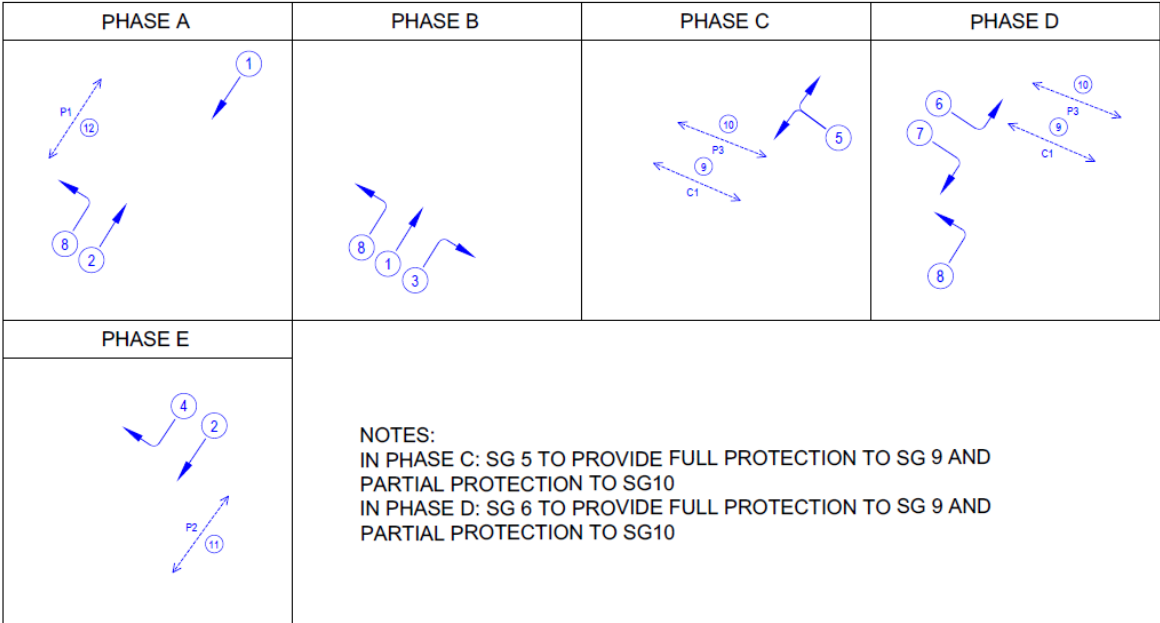
Figure 3-14: Bunny / Waterloo / Lady Elizabeth proposed phasing

| <p>Waterloo Quay does not currently run in this phase, but the proposal adds the pedestrian crosswalk (with partial protection) and the cycle crossing (with full protection) to the C phase (see Figure 3-14). The SSAT understands that Lady Elizabeth Lane experiences brief but heavy traffic peaks when a ferry unloads vehicles. The reduction from two to one lane and introduction of pedestrian and cycle crossing movements in the C phase will exacerbate the situation. This will likely result in long queues and / or substantial extensions to the C phase (depending on how exactly the intersection phasing split is operated). The extent of this cannot be confirmed without intersection modelling.</p> | 3.3.1.1 | N/A |
